**ICOMOS-ICCROM**  
ANALYSIS OF CASE STUDIES IN  
RECOVERY AND RECONSTRUCTION  
**CASE STUDIES**

Mostar, Bosnia and Herzegovina • Nablus, Palestine  
L'Aquila, Italy • Christchurch, New Zealand

**vol. 1**

# ANALYSIS OF CASE STUDIES IN RECOVERY AND RECONSTRUCTION

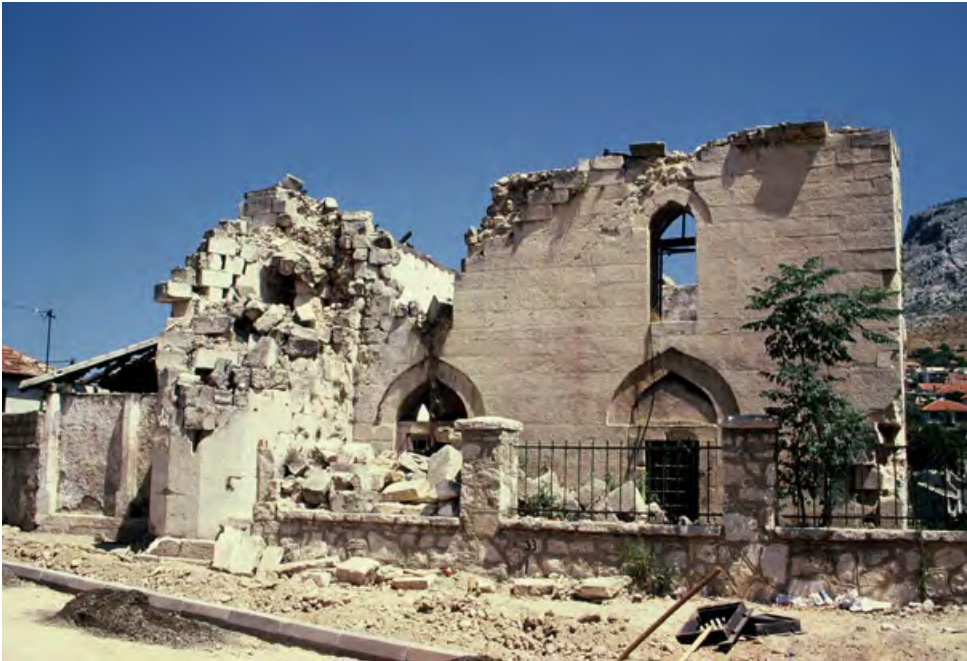
**Fig. 5.** Sevri Hadzi Hasan Mosque, after war damage

In 1992, Sevri Hadzi Hasan Mosque was the target of artillery attacks from different directions. The minaret fell on the roof and caused its collapse. Shooting from the south penetrated the *qibla* wall and destroyed the *minbar*. The flag on the *minbar* door was found in the northwest corner of the floor, under the collapsed roof. This is an indication that the mosque was attacked from the south first and the minaret was targeted later.

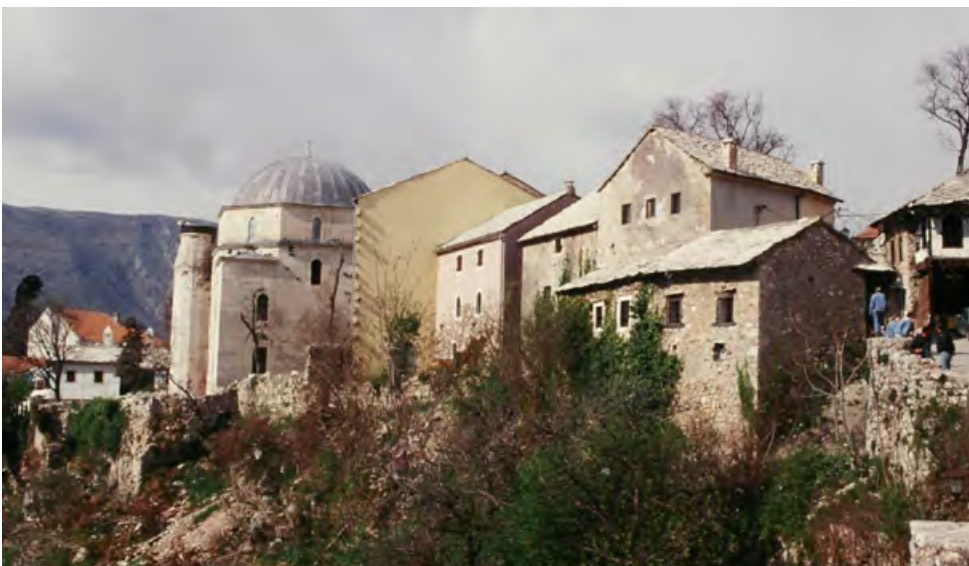
**Fig. 6.** Koski Mehmet Pasha Mosque. Minaret following emergency repair after the war

Due to damage to their domes, urgent repairs had to be conducted at Karagoz and Koski Mehmet Pasha mosques. In Koski Mehmet Pasha Mosque, the holes in the dome were repaired and the surviving base of the minaret was covered by a cap to stop penetration of water (fig. 6). Detailed studies and restoration work at Karagoz Bey and Koski Mehmet Pasha mosques were carried out later.

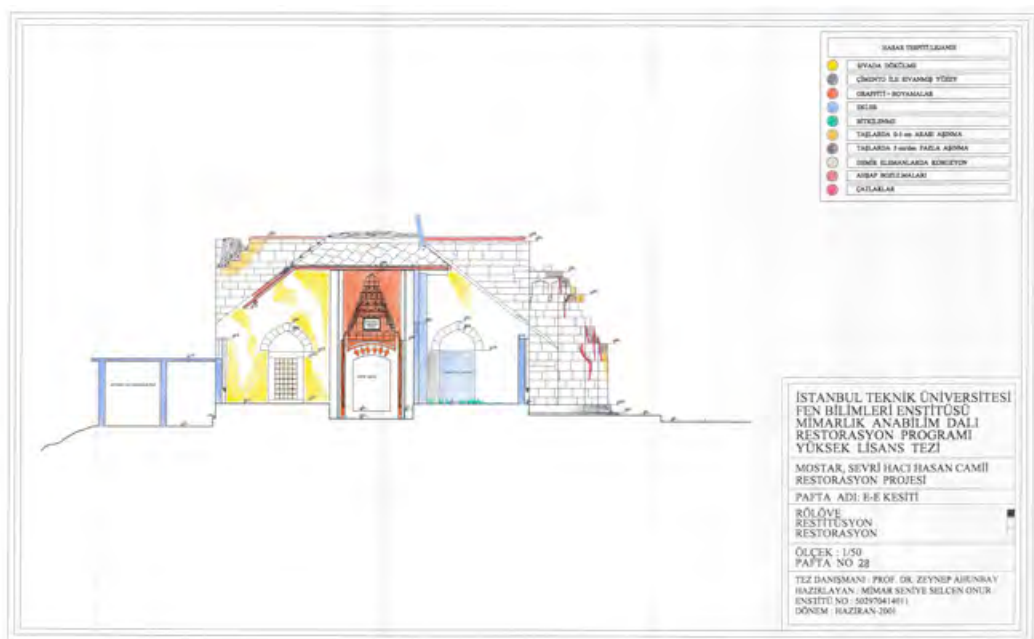
**Fig. 16.** Sevrî Hadzi Hasan Mosque, analysis of damage on the entrance façade (Architect Selcen Onur)

After recording the current state of the mosque, the work continued with the analysis of damage. There were several additions to the original fabric. Cracks, surface erosions and deformations, corroded iron elements, painted stone surfaces were noted. The damage was marked on the 1/50 scaled cross sections and elevations (figg. 16-17).

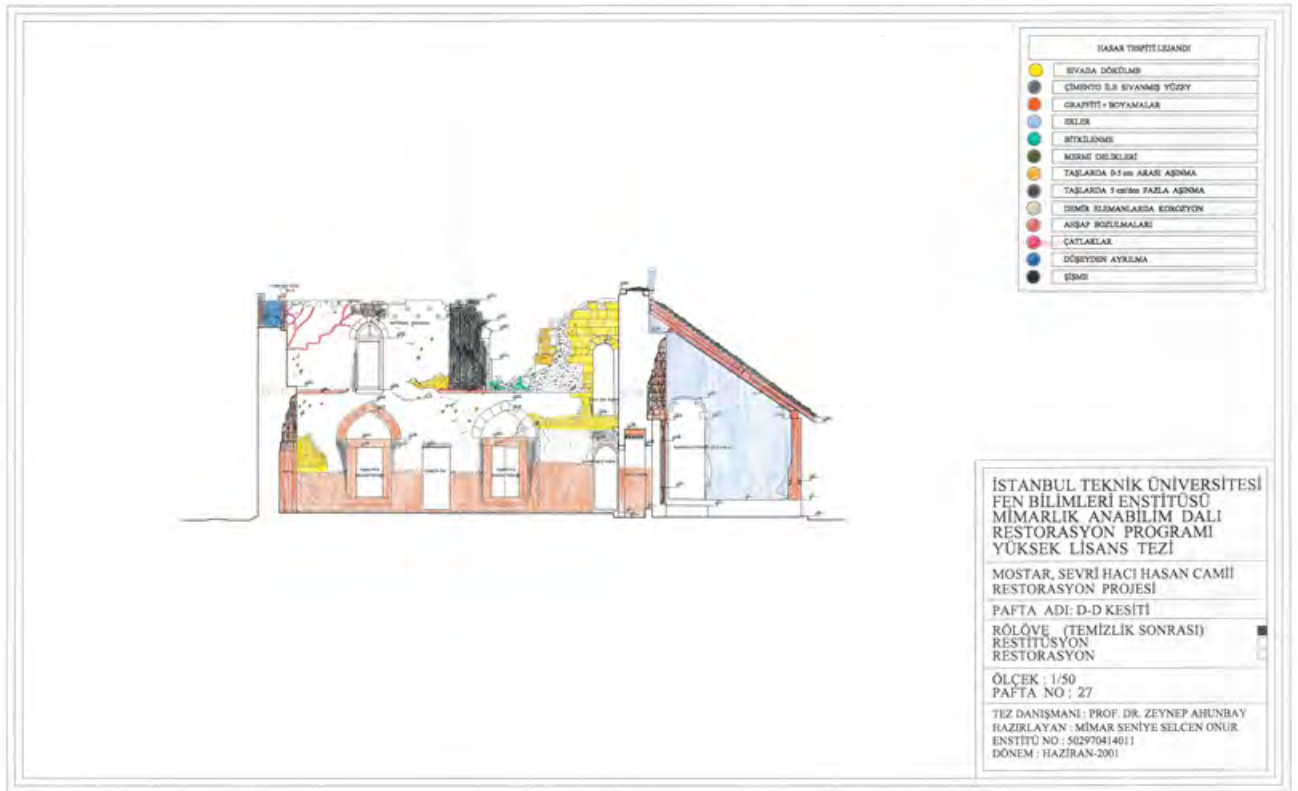
**Fig. 17.** Sevri Hadzi Hasan Mosque, analysis of damage on the north-south cross section (Architect Selcen Onur)

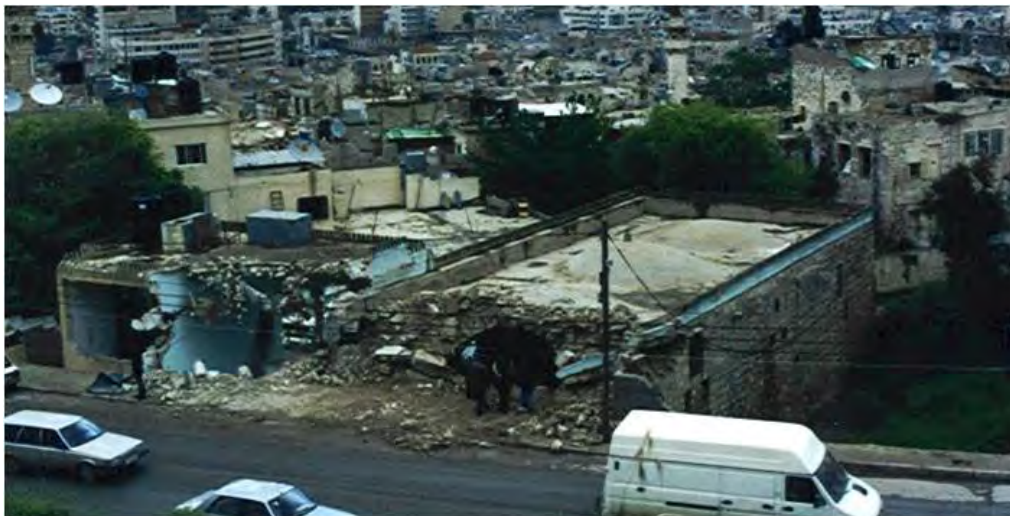
During the April invasion, large parts of the mosque’s two-metre-thick wall in the west side of the main prayer hall were destroyed by an Israeli tank. This was followed by a bulldozer that demolished the main façade as well, and caused partial roof collapse, affecting the stability of the building (figg. 48-50).

Images, Clockwise from top left:  
Figg. 48-50. Al Khadra Mosque

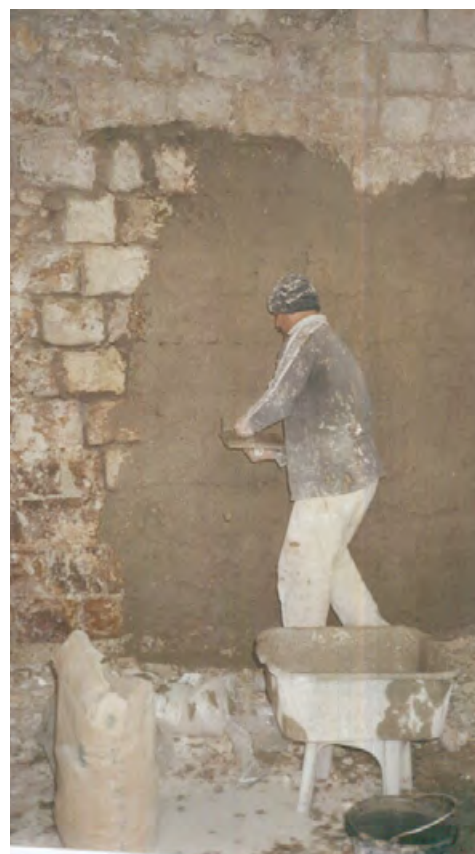
3. The ministry did not have staff who were specialists in restoration work, which led to the removal of old stones and doors according to engineering visions that often contradicted the principles of restoration. Old wooden doors and windows were replaced by new aluminium and metal sheets, cement was widely used to stabilise buildings instead of stone (figg. 74-77).

►  
**Images, Clockwise  
from top left:**  
**Figg. 74-77.** The use of  
cement mortar and new  
materials for stabilisation  
and repair work

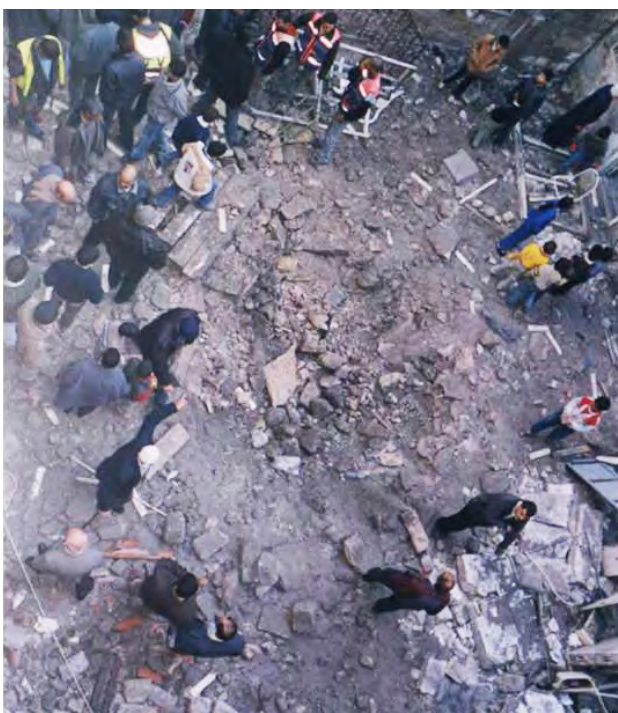
**Fig. 78.** Using concrete to stabilise demolished structure

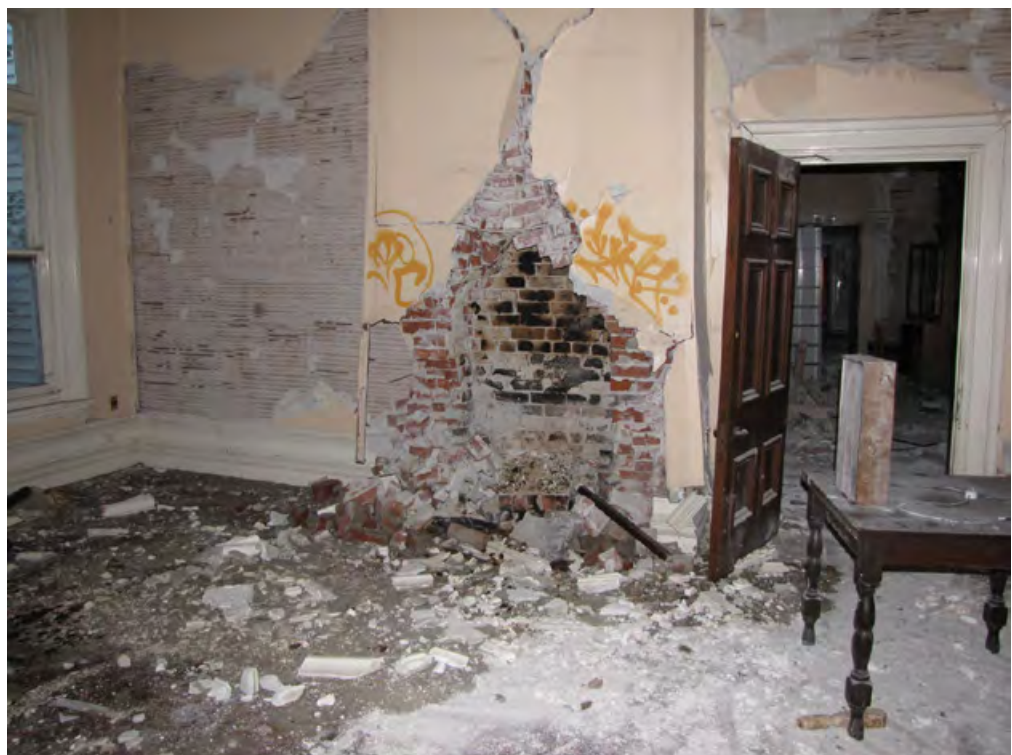
► **Fig. 25.** Brick fireplaces have collapsed (Source: W. Clark, 24/11/2015)

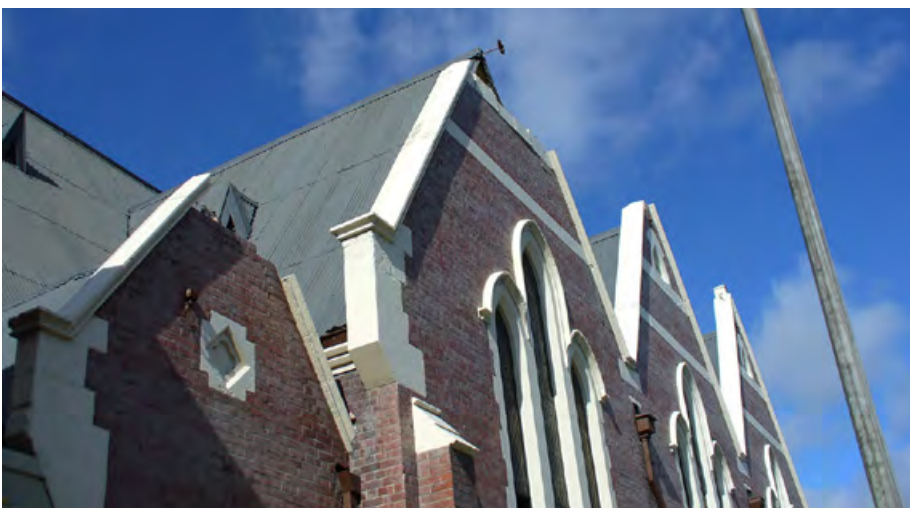
**Fig. 6.** September 2010 earthquake damage to northern gables (Source: CCC, 27/1/2011)

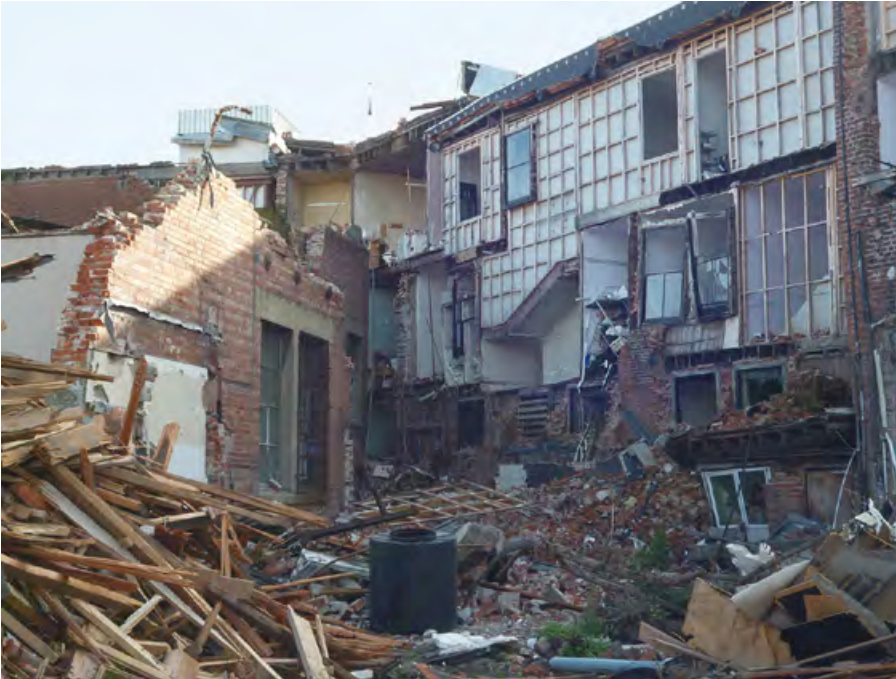
**Fig. 8.** The unreinforced masonry structures to the rear of the McKenzie and Willis facade have collapsed (Source: Carole-Lynne Kerrigan, n.d.)

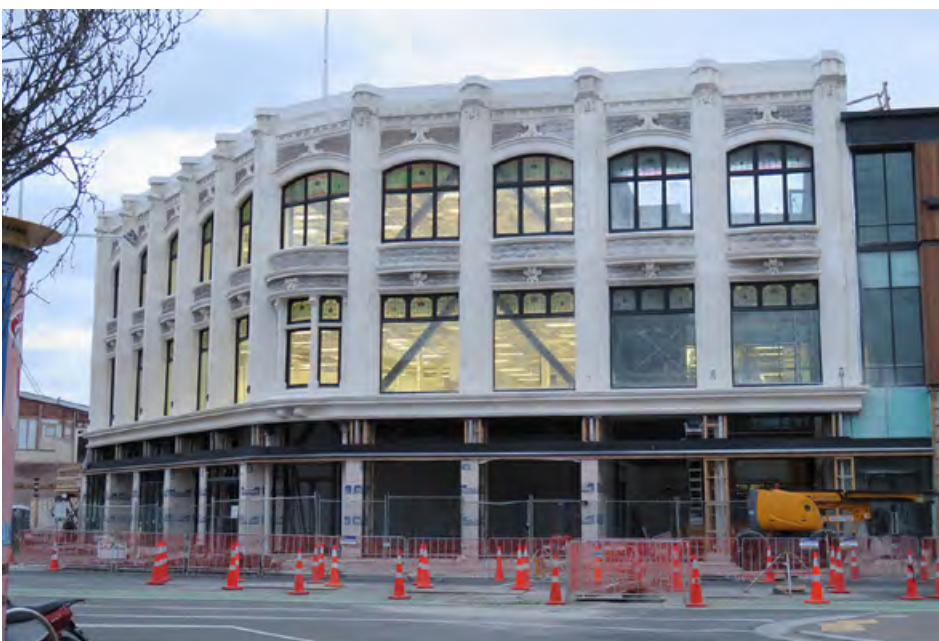
**Fig. 15.** Restored façade with construction of new building occurring behind. The steel braces supporting are clearly visible through the windows (Source: C. Forbes, 13 September 2016)

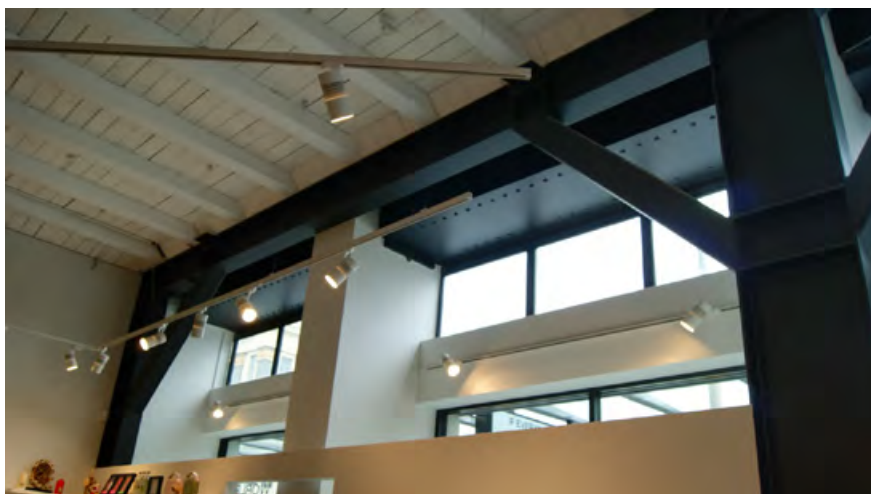
**Fig. 20.** Detail of steel support structure behind the façade (Source: A. Ohs, 21 November 2019)
