ANALYSIS OF CASE STUDIES IN
RECOVERY AND RECONSTRUCTION

CASE STUDIES

Patan, Nepal • Taishun, China • Nyanza, Rwanda
Aleppo, Syria • San Pedro de Alcántara, O'Higgins Region, Chile
WH Cultural Landscape Wachau, Austria • San Luis Potosí, México

VOL. 2

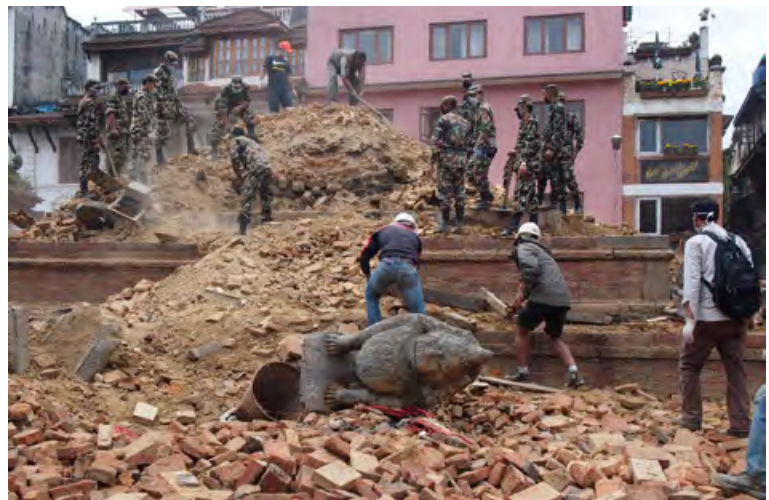
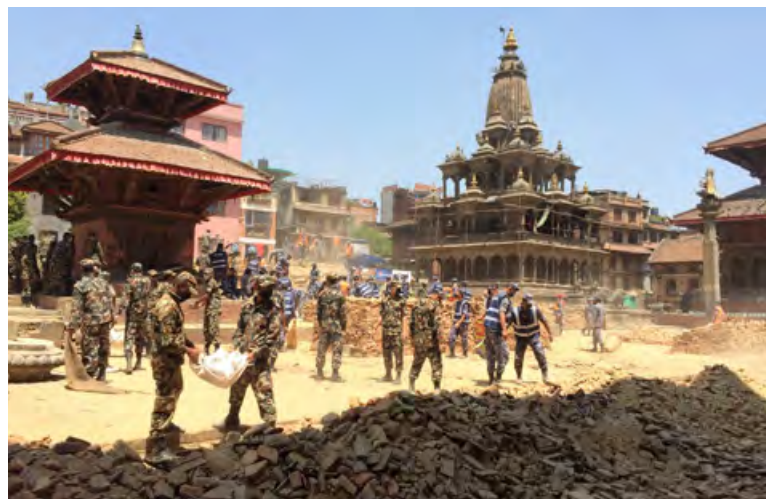
► **From top to bottom:**
Fig. 17. Artefacts and decorative components were manually recovered from the debris of collapsed temples (Thomas Schrom, 2015)
Fig. 18. The recovery of elements was jointly carried out with the help of local stakeholders, the local community, the Nepal Army, the Armed Police Force and the Police (Kathmandu Valley Preservation Trust, 2015)

It is notable that in the immediate aftermath of the earthquake well-organised local communities started not only to rescue human beings but also to recover and secure unique architectural elements like statues and carved wooden elements (Manhart 2018). Some local people even rushed to the site immediately after the earthquake to protect artefacts from theft. The overall rescue and recovery of works of art was coordinated by the DoA together with the KVPT. It was carried out with the help of local stakeholders, the local community and the Nepal Army, the Armed Police Force and the Police (figg. 17-18).

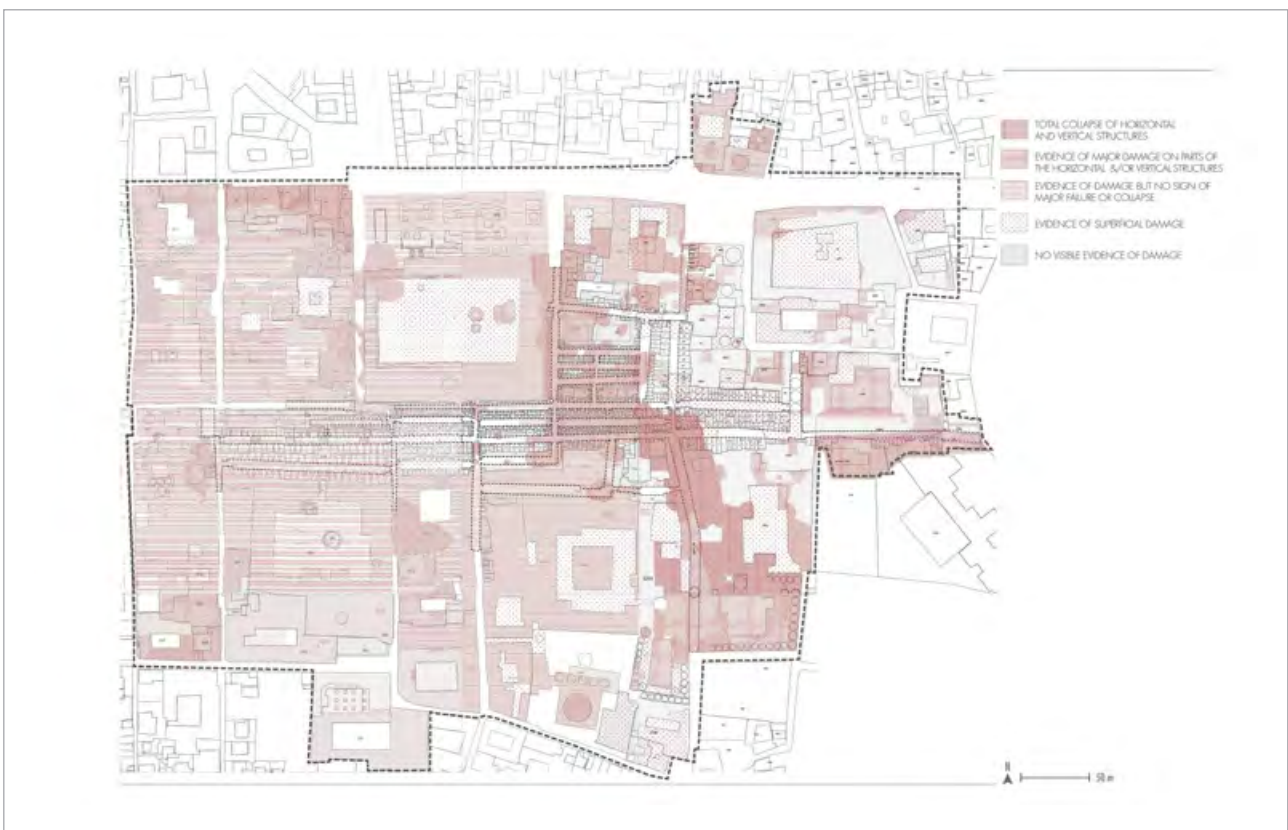
Fig. 4. The Central Commercial Zone: the levels of damage based on the assessment carried out by AKTC in 2017, (courtesy of AKTC)

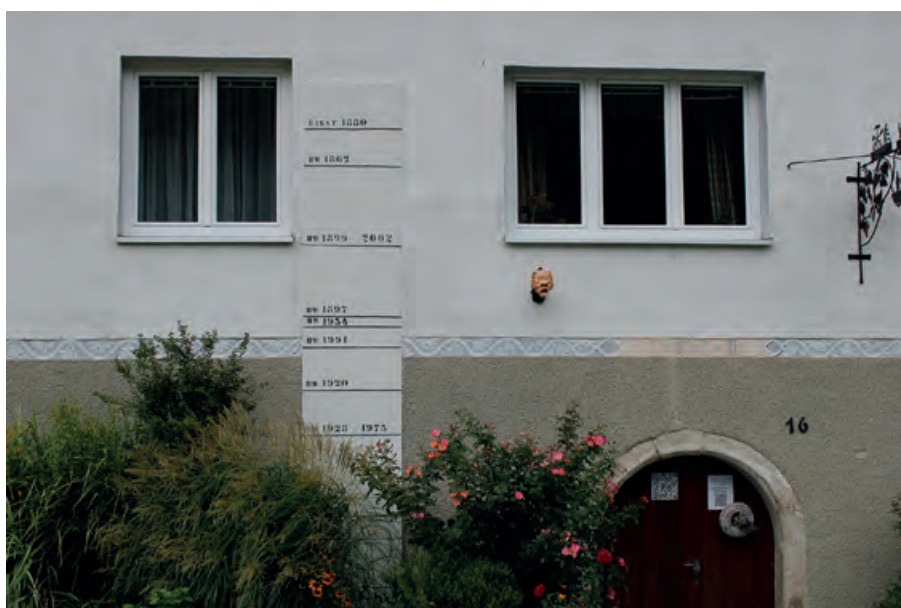
◀
Fig. 2. M. Schimek, 2019,
Flood marks at the house
Oberarnsdorf 16

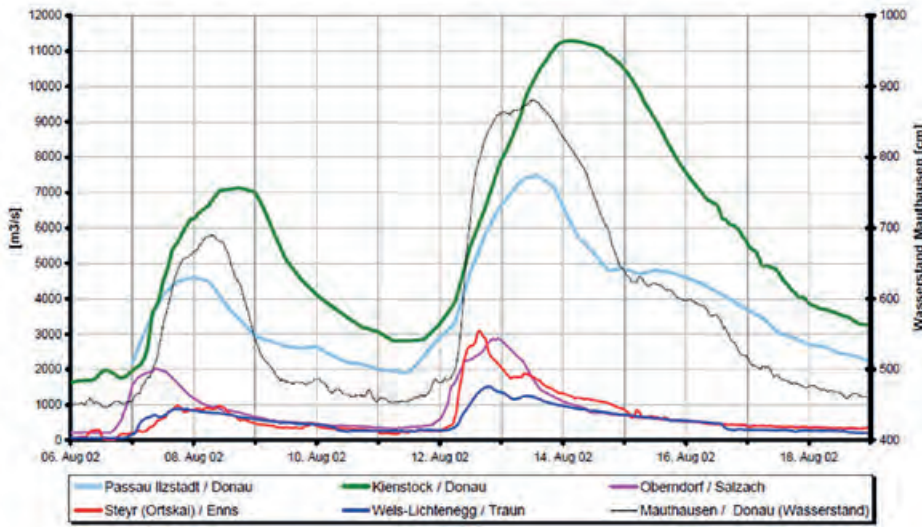
◀
From top to bottom:
Fig. 4. The August 2002 flood on the Danube, in: Godina *et al.* 2004, 32
Fig. 5. Flood levels in August 2002 from the Wachau downwards, in: Godina *et al.* 2004, 33

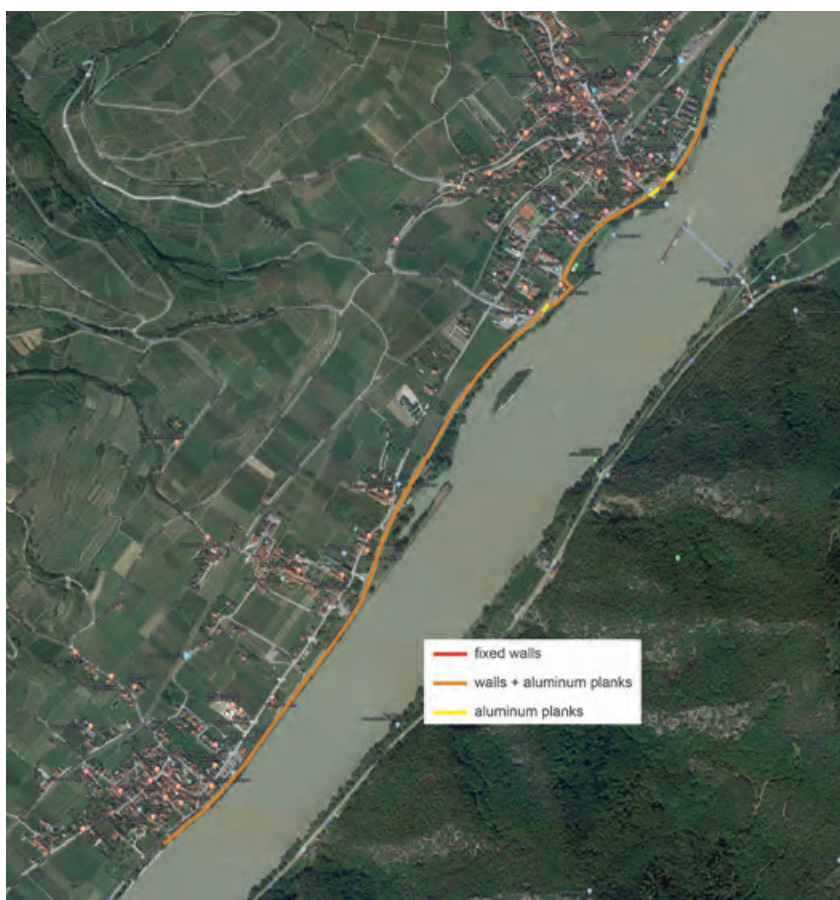
▲
Images, Clockwise from top left:
Fig. 21. Google Maps, cartography M. Schimek, 2019, Flood protection system at Weißenkirchen, Joching, and Wösendorf
Fig. 22. M. Schimek, 2019, Flood wall in the relatively open land near Joching
Fig. 23. M. Schimek, 2019, The flood gate at Wösendorf
Fig. 24. M. Schimek, 2019, Aluminum panel storage hall near Joching

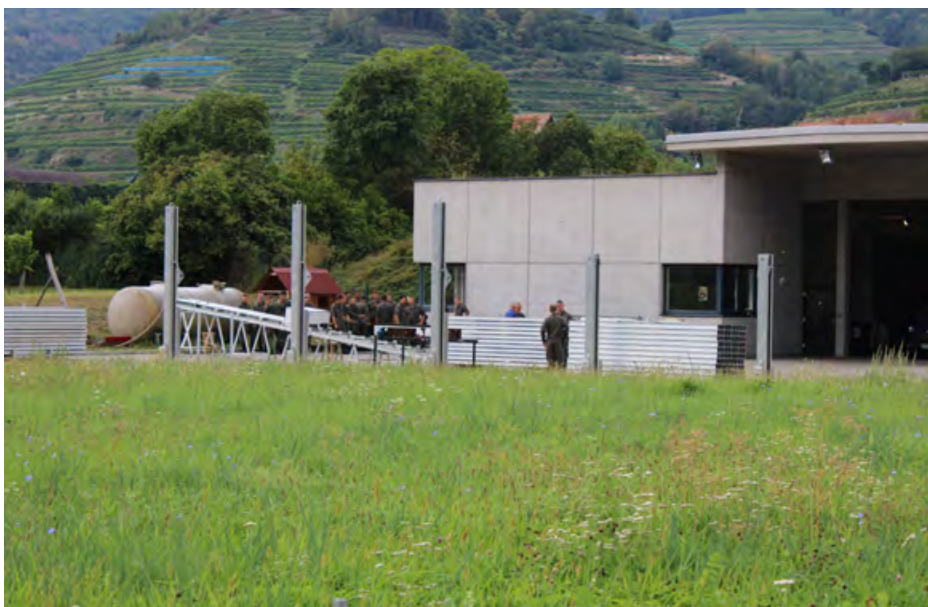
Fig. 36. M. Schimek, 2019, Aluminum plank washing machine at work during a practice with the Austrian army in Weißkirchen
