**ICOMOS-ICCROM**  
ANALYSIS OF CASE STUDIES IN  
RECOVERY AND RECONSTRUCTION  
**CASE STUDIES**

Mostar, Bosnia and Herzegovina • Nablus, Palestine  
L'Aquila, Italy • Christchurch, New Zealand

**vol. 1**

# ANALYSIS OF CASE STUDIES IN RECOVERY AND RECONSTRUCTION

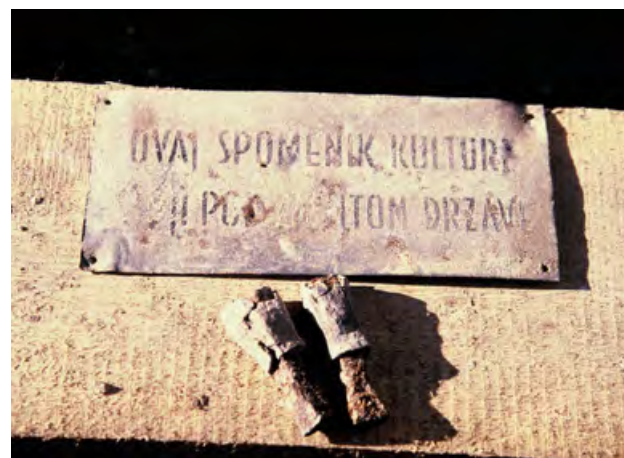
The socialist regime of Yugoslavia restricted the practice of religion, but mosques designated as cultural assets continued to live on. A metal sign which bore the name of the Sevri Hadzi Hasan Mosque was found among the ruins (fig. 3).

**Fig. 3.** Metal sign for Sevri Hadzi Hasan Mosque, recovered from the ruin with two dowels found in the rubble

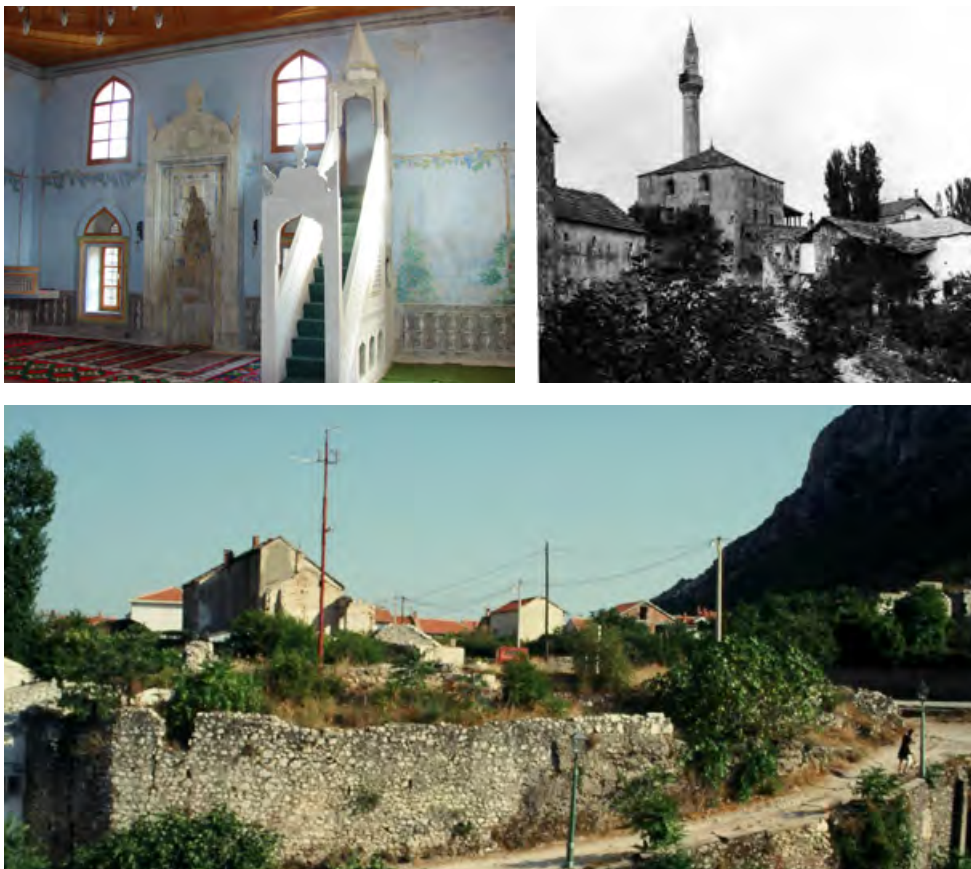
**Fig. 7.** Tabacica Mosque, interior after reconstruction of the dome

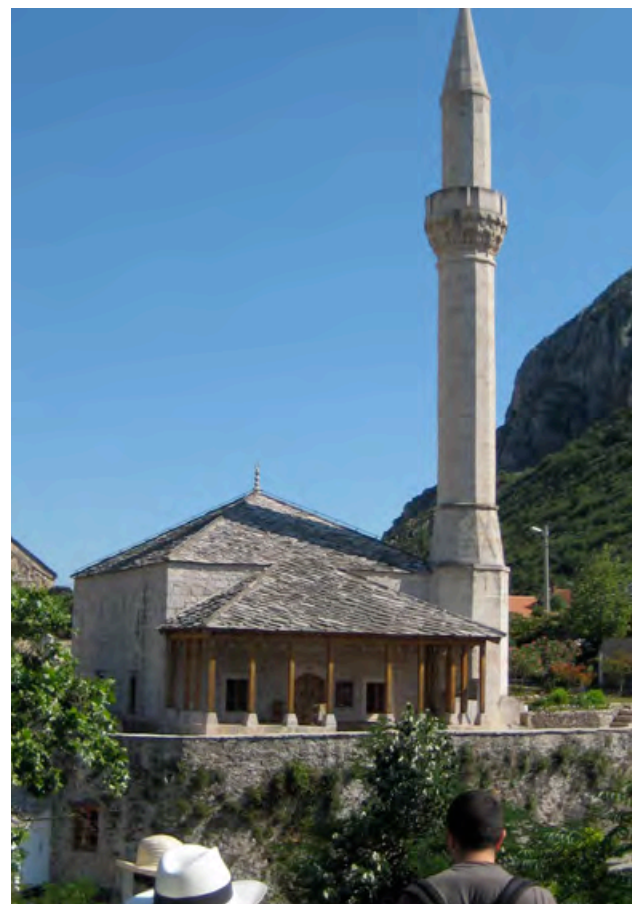
The reconstruction of Nezir Aga Mosque was an important project for the urban revival of Mostar. Its location, articulated mass with an elegant timber porch and hipped roof contribute greatly to the appreciation of the cityscape (fig. 10). The emergence of a long-lost monument enlivened the area and made the citizens happy. They rejoiced at the inaugural ceremony on 10 September 1999, at which a representative of the donor H. H. Sheikh Dr Sultan Al Qassimi, the mayor of Mostar and members of the Islamic Community of BiH participated.

Fig. 10. Nezir Aga Mosque from the north, after reconstruction

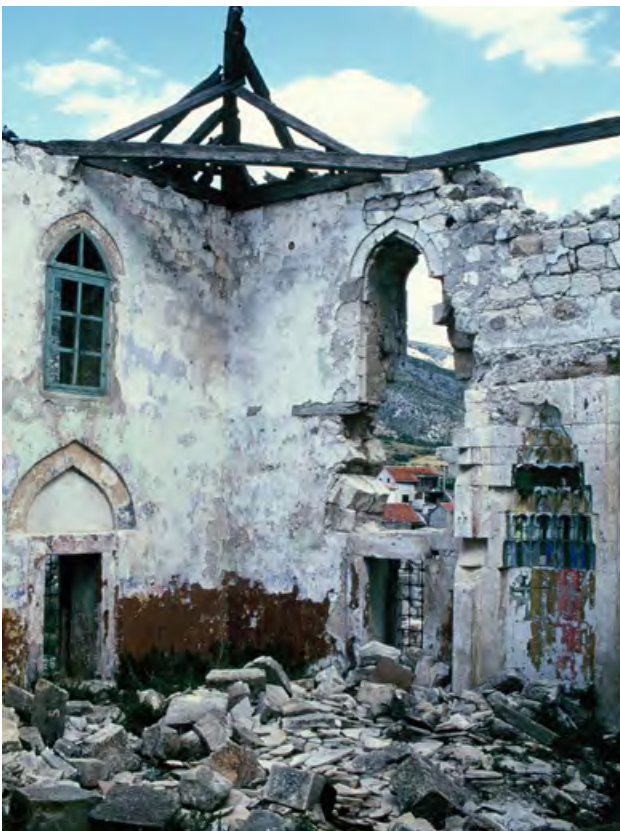
The masonry walls were reinforced with timber lacing at two levels. The timber runner beams on top of the walls were partially in place. The roof had collapsed but at the northeast corner, the lower part of the timber structure was preserved (fig. 14). The surviving portion provided information about the size of the ridge beams and the inclination of the timber roof. The evidence preserved at the northeast corner could help with the reconstitution of the hipped roof.

**Fig. 14.** Sevri Hadzi Hasan Mosque, the northeast corner of the roof

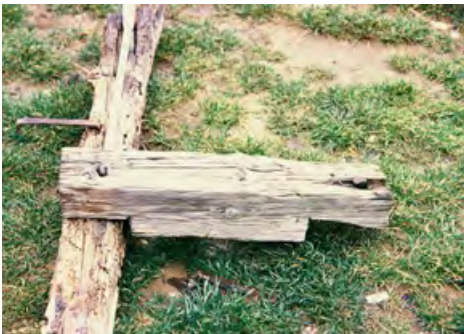
**Fig. 22.** Sevri Hadzi Hasan Mosque, timber lacing removed from the top of the *qibla* wall

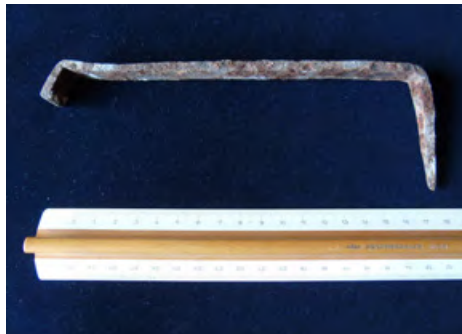
**Fig. 23.** A clamp from the top of the southwest wall. The special detailing with different ends is noteworthy. The end fixed to the stone was broken; so it is shorter than the other

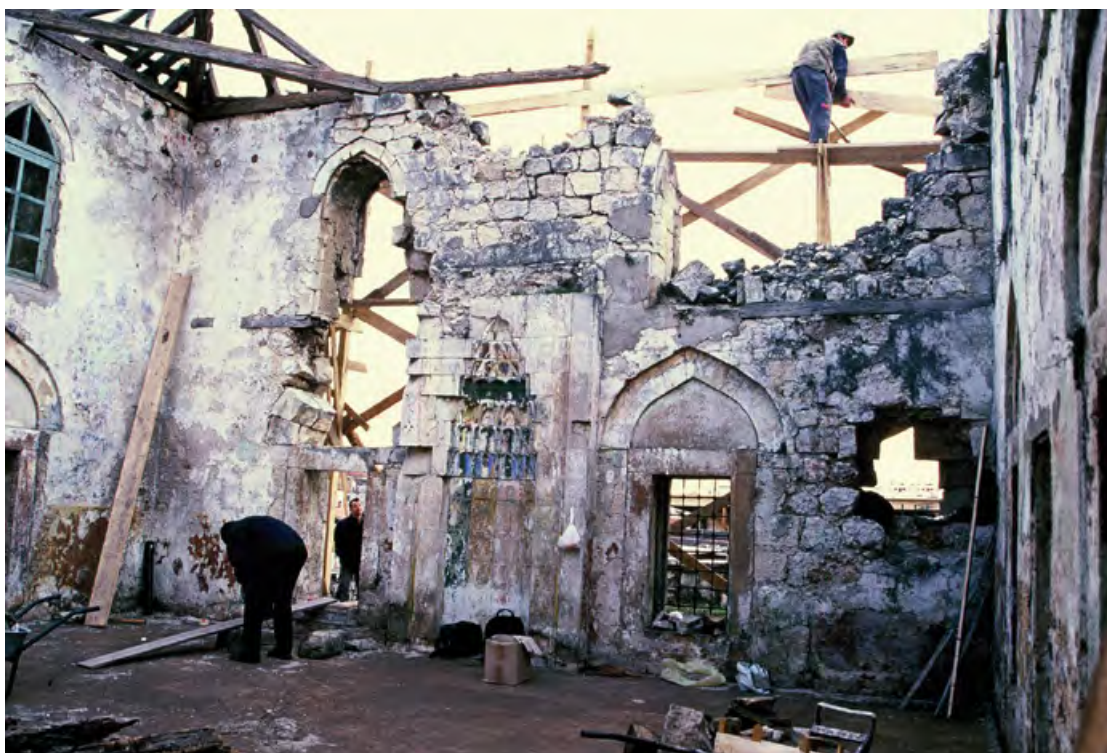
▲  
**From top to bottom:**  
**Fig. 27.** Starting to work on the *qibla* wall  
**Fig. 28.** Pouring molten lead to fix a clamp

The broken column of the porch had to be restored. The walls, which had been penetrated and cracked by shooting had to be consolidated and reintegrated (fig. 27). Mostar is a town with a long tradition in stone building. The local craftsmen had developed skills in using and carving stone.

The missing parts of the walls were reconstructed using the same kind of stone and the same quality of surface finishing. Ashlar blocks were used on the exterior and roughly cut stones on the inner surfaces of walls. Cracks were stitched by stainless steel clamps and fixed into position with molten lead (fig. 28). In order to achieve good bonding between the old masonry and the reconstructed sections like the southwest corner of the walls, new blocks were connected to the existing masonry by stainless steel clamps. The stability of the walls was checked by structural engineers Salko Kulucija and Mustafa Humo from the INTERPROJECT company in Mostar. They were interested in and had experience in the conservation of historic structures. They were consulted for their opinion on the reconstruction proposal for the roof. After checking the project for the dome of Sevril Hadzi Hasan Mosque, they proposed to increase the cross-section of the timber runner beams at the top of the masonry walls. Thus, the base of the timber dome was strengthened owing to the safety concerns of the structural engineers.

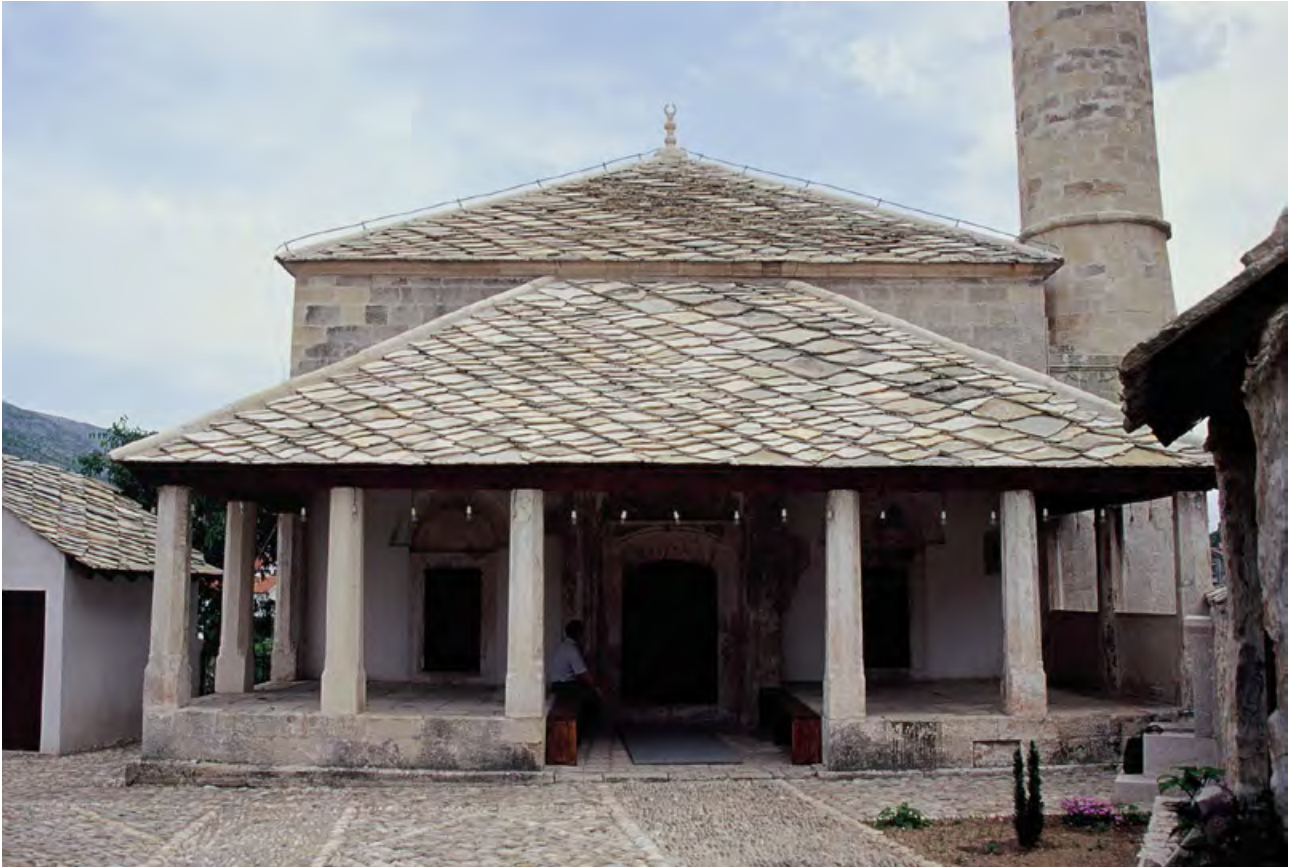
**Fig. 29.** View from the north after restoration

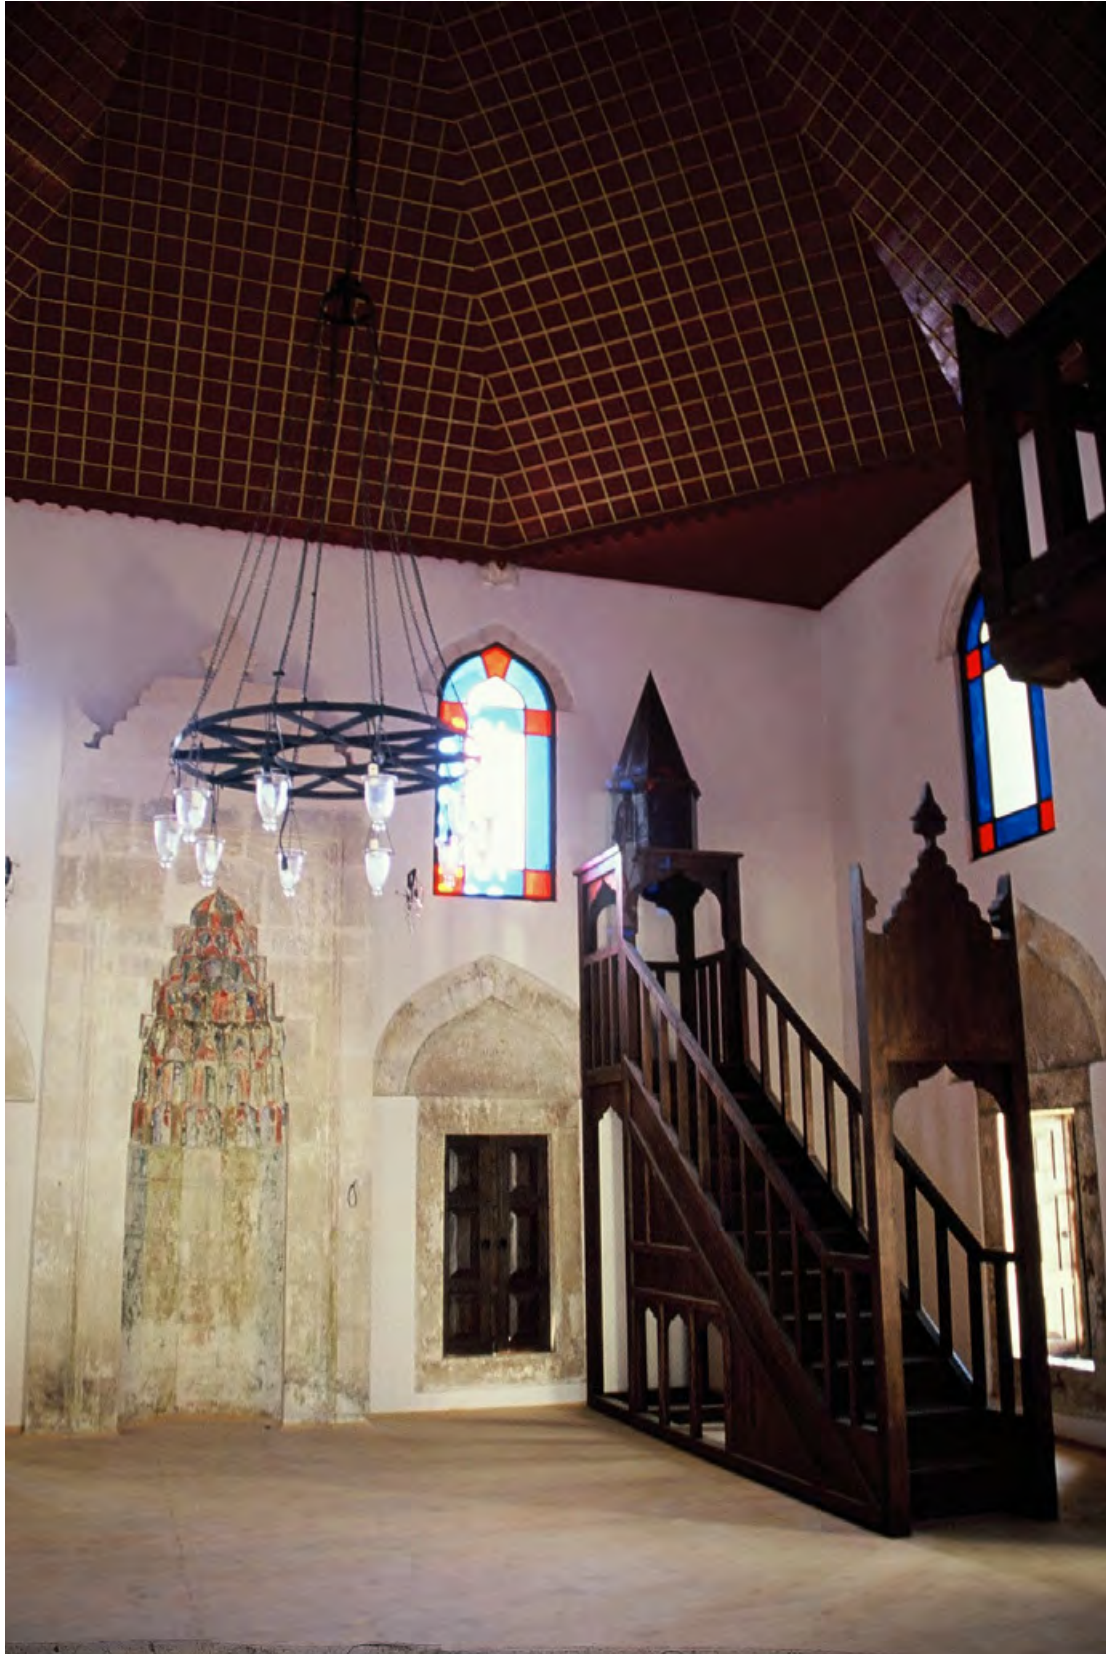
Fig. 30. Interior with the reconstructed minbar and the dome

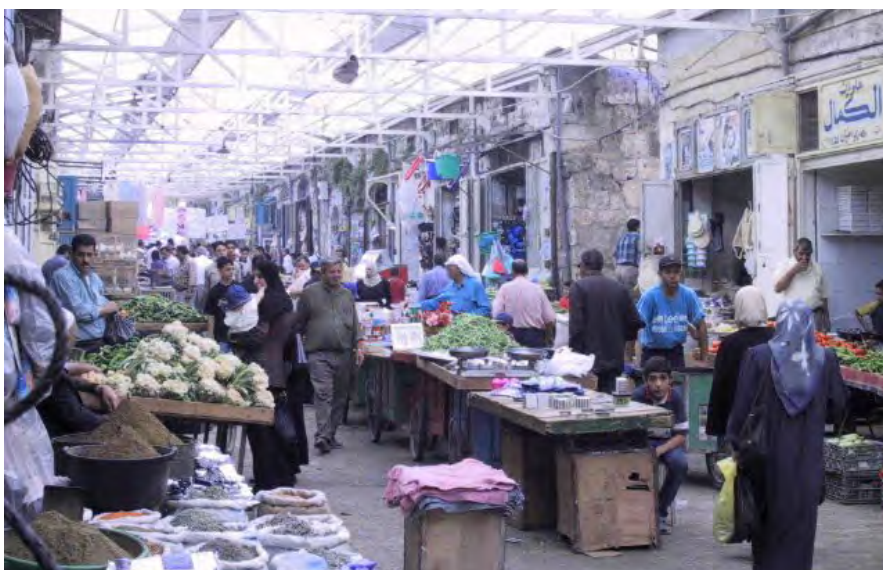
**Fig. 16.** Metal Structure above the main street in the eastern part of the Old City

Despite the positive impact of this project, the architectural design of these covers did not take into consideration the traditional style of the buildings. The unified structure used flat shapes which were not in tune with the authentic view of the traditional organic shapes of the building façades facing the winding streets of the Old City (fig. 16).

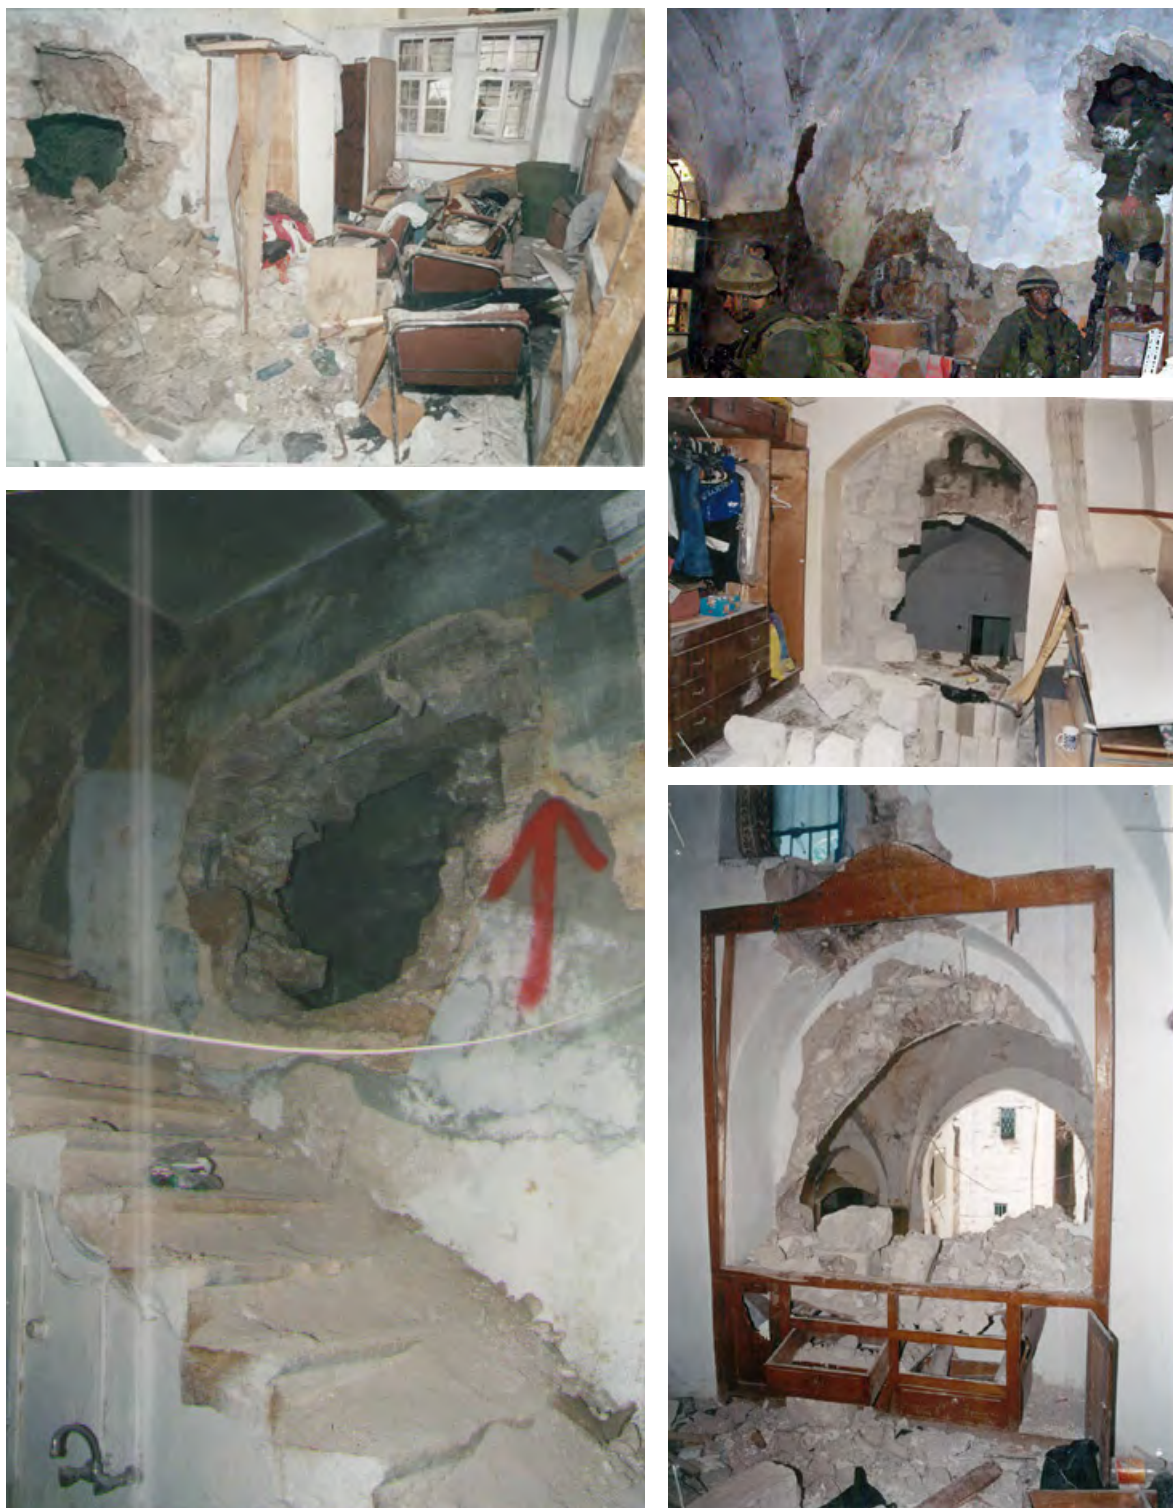
**Figg. 22-26.** Several photos showing how the Israeli forces moved from one house to the other using explosive to make holes in adjacent walls

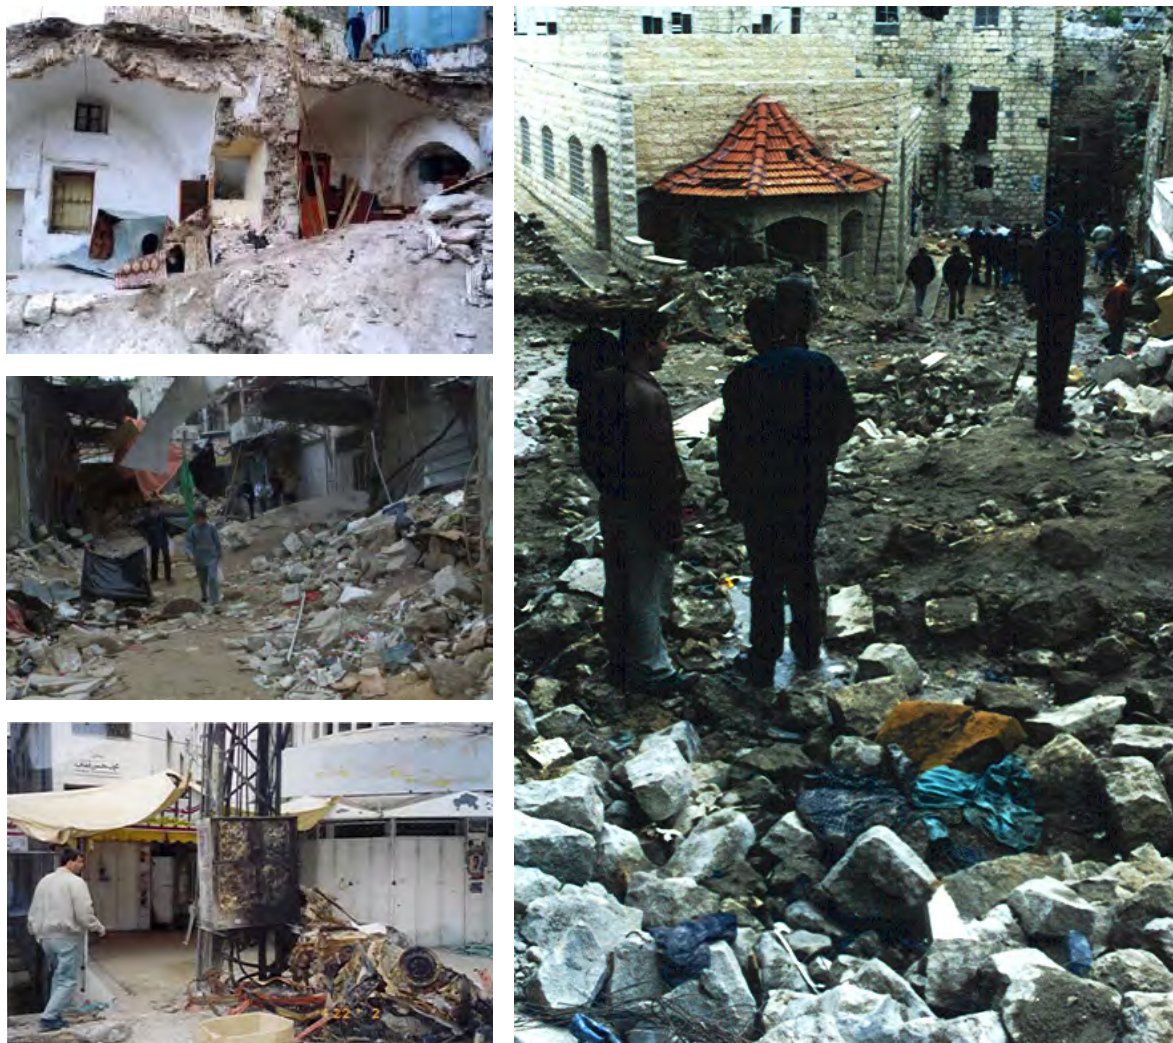
**Figg. 27-28.** Views of the destruction of a number of houses

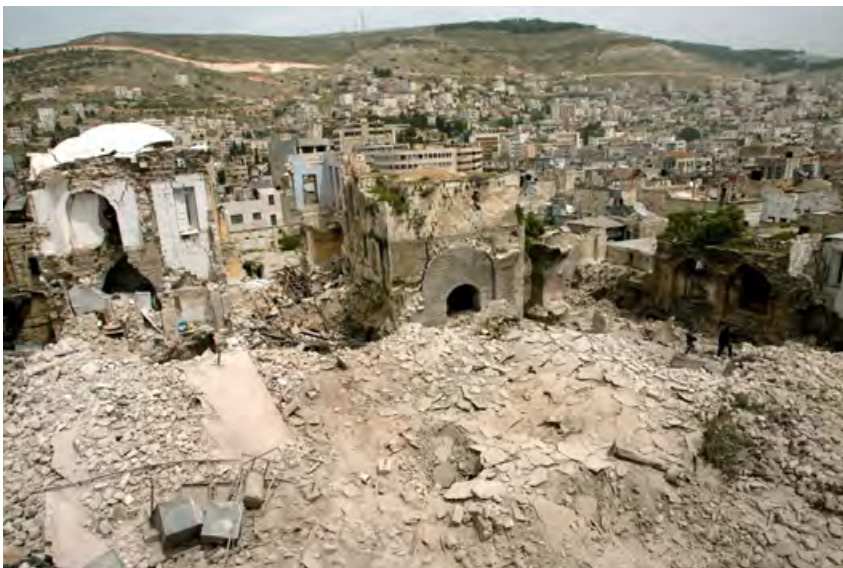
**Fig. 31.** The site of the two soap factories and adjacent houses destroyed in 2002 invasion

The Greek Orthodox Church was badly affected by the demolition of two soap factories (Kannan and an-Nabulsi) in the western part of the Old City. The destroyed factories were two of the city's soap factories. The destruction affected 3,500 square metres of built-up areas in adjacent buildings. The soap factories were destroyed by heavy bombing on the night before the Israelis evacuated the Old City on 21 April 2002. The incident not only completely destroyed the soap factories but also nine adjacent houses along with the inhabitants' furnishings and belongings (fig. 31).

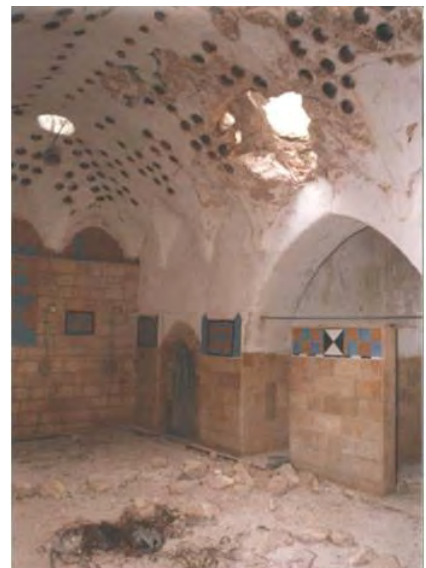
**Fig. 32.** Ash-Shifa Turkish bath hit by a clever missile that demolished the roof of hot room

1795) and restored in 1992 was hit by two helicopter *smart* missiles, creating large holes in the vaulted roof. The damage has seriously affected the stability of the structure and its unique architectural design (fig. 32).

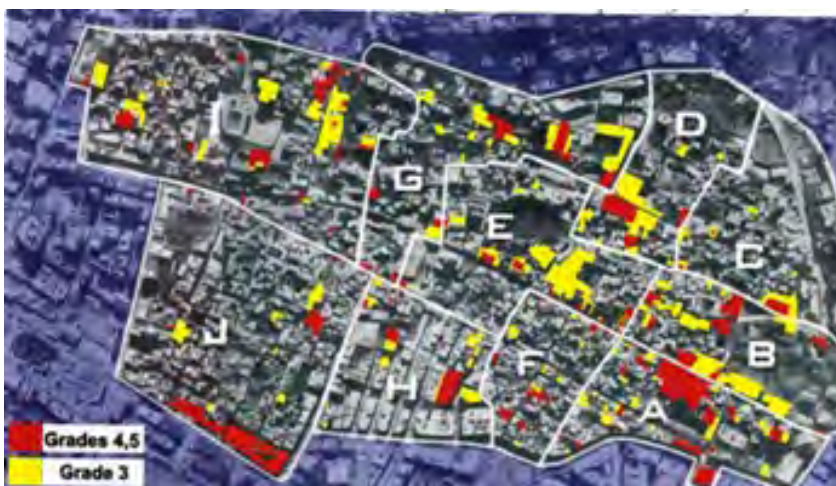
**Fig. 38.** Map of the Old City showing locations of destroyed buildings

The assessment classified the damage into three grades (3, 4 and 5). Grade 3 refers to light damage, grades 4 and 5 refer to moderate and severe damage respectively. Ten sub-groups covered the historic city based on a defined zone for each group. The following map shows the sites of destruction which indicates the widespread nature of the destruction all around the Old City (fig. 38).

It was extremely difficult to draw boundary lines between buildings; damage of any part of one house can affect other units of those adjacent, above or underneath. However, the result of the assessment works concluded, as follows:

- 64 buildings or groups of buildings suffered heavy structural damage or were totally destroyed (grades 4 and 5).
- 221 buildings or group of buildings suffered some structural damage and were unsafe, needing urgent repair and renovation. More could have become unsafe during the winter when water penetrates cracked walls.

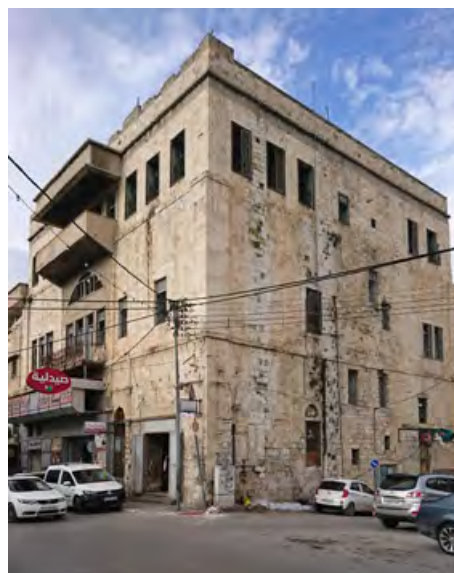
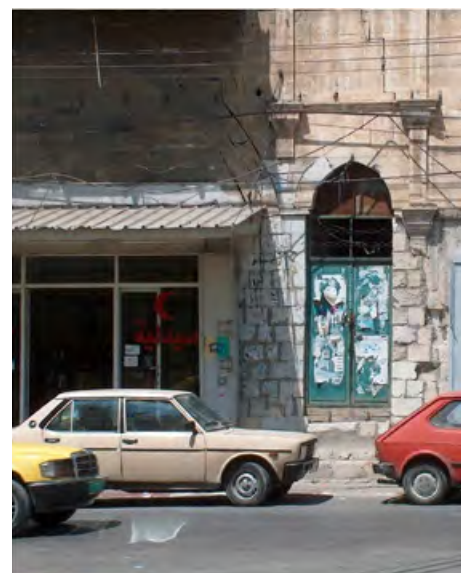
►  
Images, Clockwise  
from top left:  
**Figg. 45–46.** Tanks in  
the main street in front  
of Qamhawi house  
**Fig. 47.** The main entrance  
of Qamhawi house  
after it was repaired  
**Fig. 47a.** The Qamhawi  
house today

immediately after the Israeli army moved away from the street by reusing stones saved from the same building; a minimal amount of cement and building materials were needed, the labour cost was also very small (fig. 47). The impact of such work was enormous; the whole building was saved from collapse. If this work had not been done immediately, the building could have suffered from more cracks that would have increased rapidly because of the adjacent high traffic on the street. This could have caused the total collapse of the main façade and many other parts of the building. Although the building is completely abandoned, it was saved, but no further work has been done to restore it (fig. 47a).

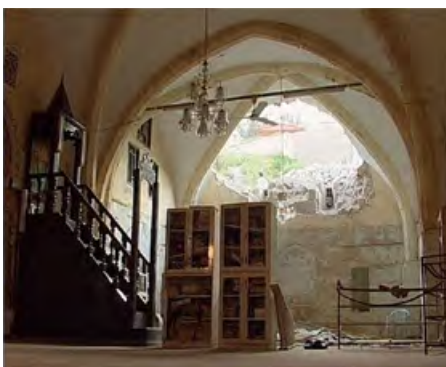
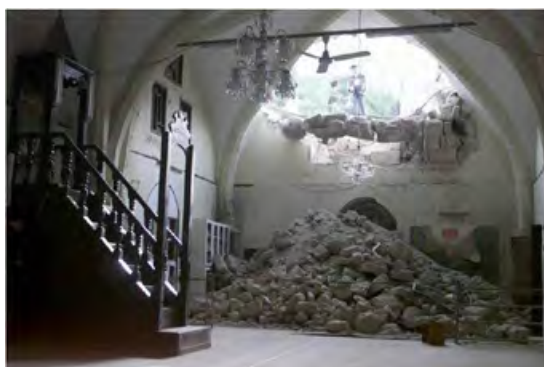
Images, Clockwise from top left:  
Figg. 48-50. Al Khadra Mosque

During the April invasion, large parts of the mosque’s two-metre-thick wall in the west side of the main prayer hall were destroyed by an Israeli tank. This was followed by a bulldozer that demolished the main façade as well, and caused partial roof collapse, affecting the stability of the building (figg. 48-50).

Despite the terrible situation and the scarcity of personal resources and finance, the people of the neighbourhood formed a committee and collected the money needed for emergency repairs to the building. Immediately after the destruction, people cleared the rubble, stored the good stones that could be used for the reconstruction work, and local building professionals repaired the roof and the higher part of the original wall of the historic building. This stabilised the building and prevented further failure that could have happened. This immediate act saved the main hall from further damage. This work was implemented by using cement mortar for the roof and whatever original stones were saved for the upper wall of the main hall. It was surprising to learn that the money collected was even more than what was needed for the stabilising work. As a result, work continued on building a new façade and a more beautiful entrance than the brick one built in 1975. The previous façade was adjacent to the historic building made of brick; part of it was for a newly built room above the level of the historic building to the northern side of it. The new construction was made of new lime white stone. This new look of the upper façade of the building has given a better image than the previous one.

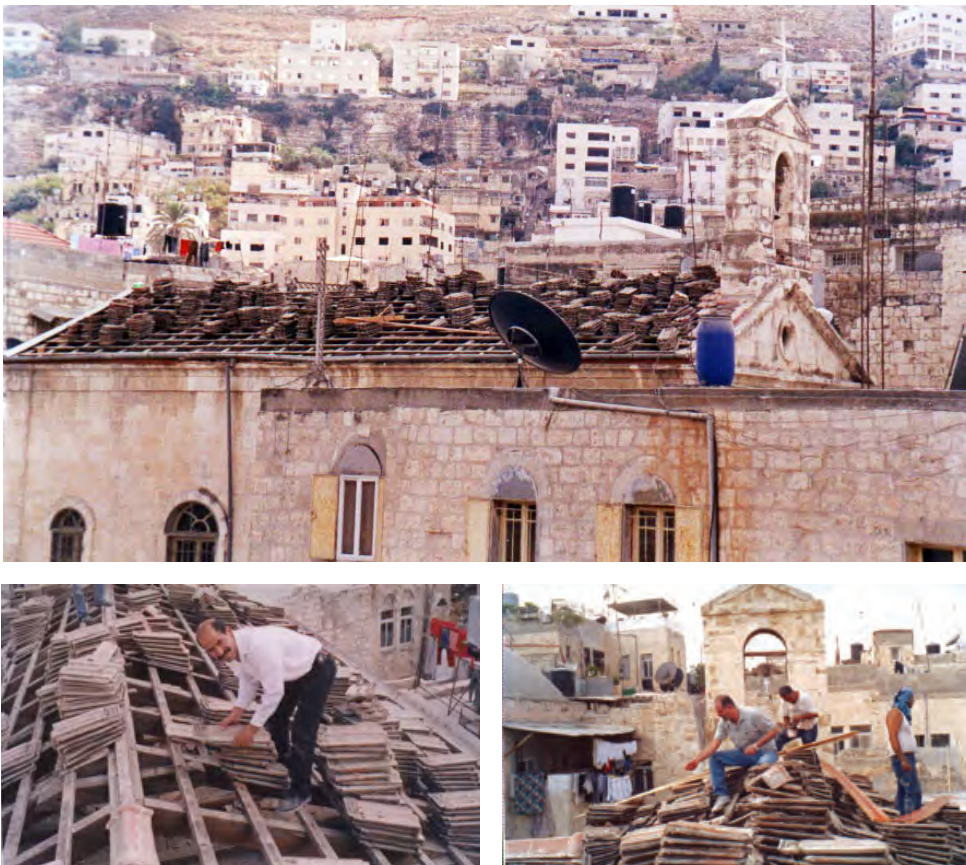
**Figg. 52–54.** Immediate repair and construction of the roof of the Greek Orthodox Church

The roof was retiled with matching existing tiles and new ones where necessary. The wooden structure which supports the ceiling underneath was repaired as well. The repair work was carried out just in time: soon after the work was completed, an estimated third of the region's annual rainfall fell in Nablus. The emergency relief provided prevented damage to the ceiling (fig. 55).

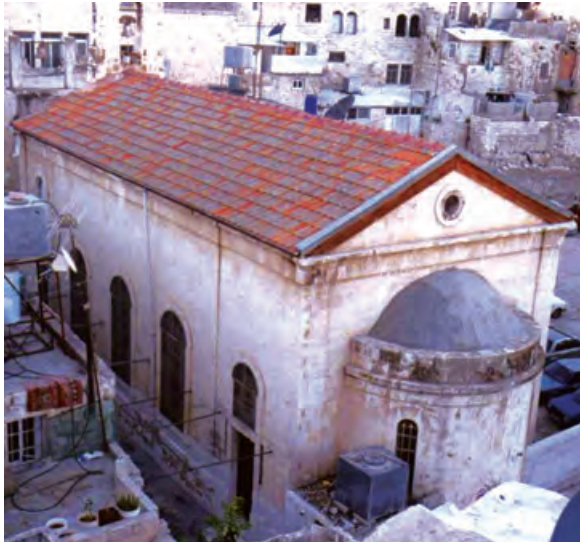
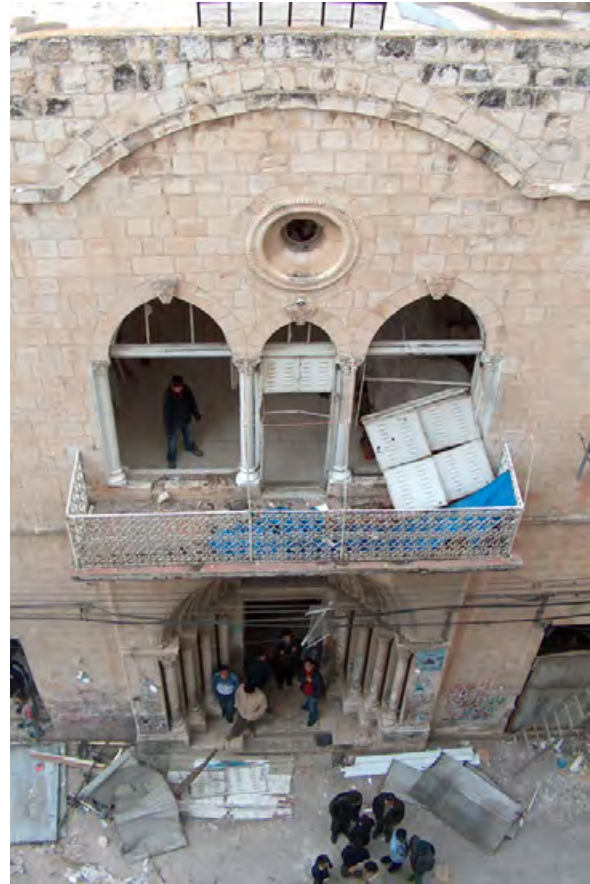
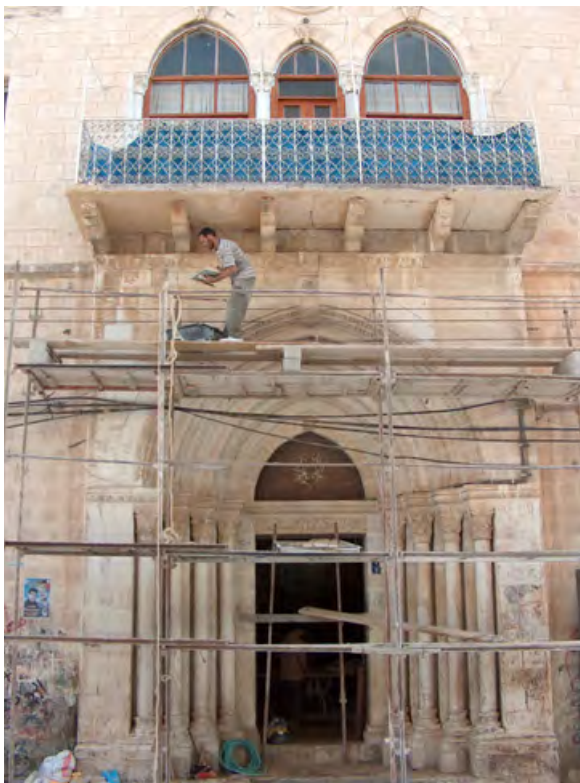
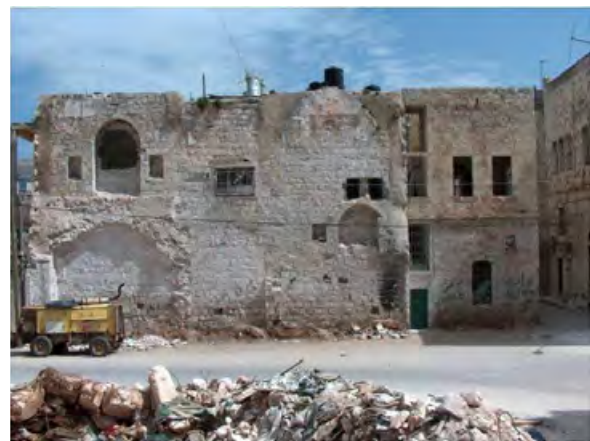
**Fig. 55.** The Greek Orthodox Church roof after it was fixed by the author

The massive explosion by Israeli forces in January 2005, which completely destroyed the home of the Shak'a family opposite, caused partial damage and serious cracks to the building. It threatened more comprehensive damage to the house that would have been a major loss for the city's architectural heritage (figg. 56–58).

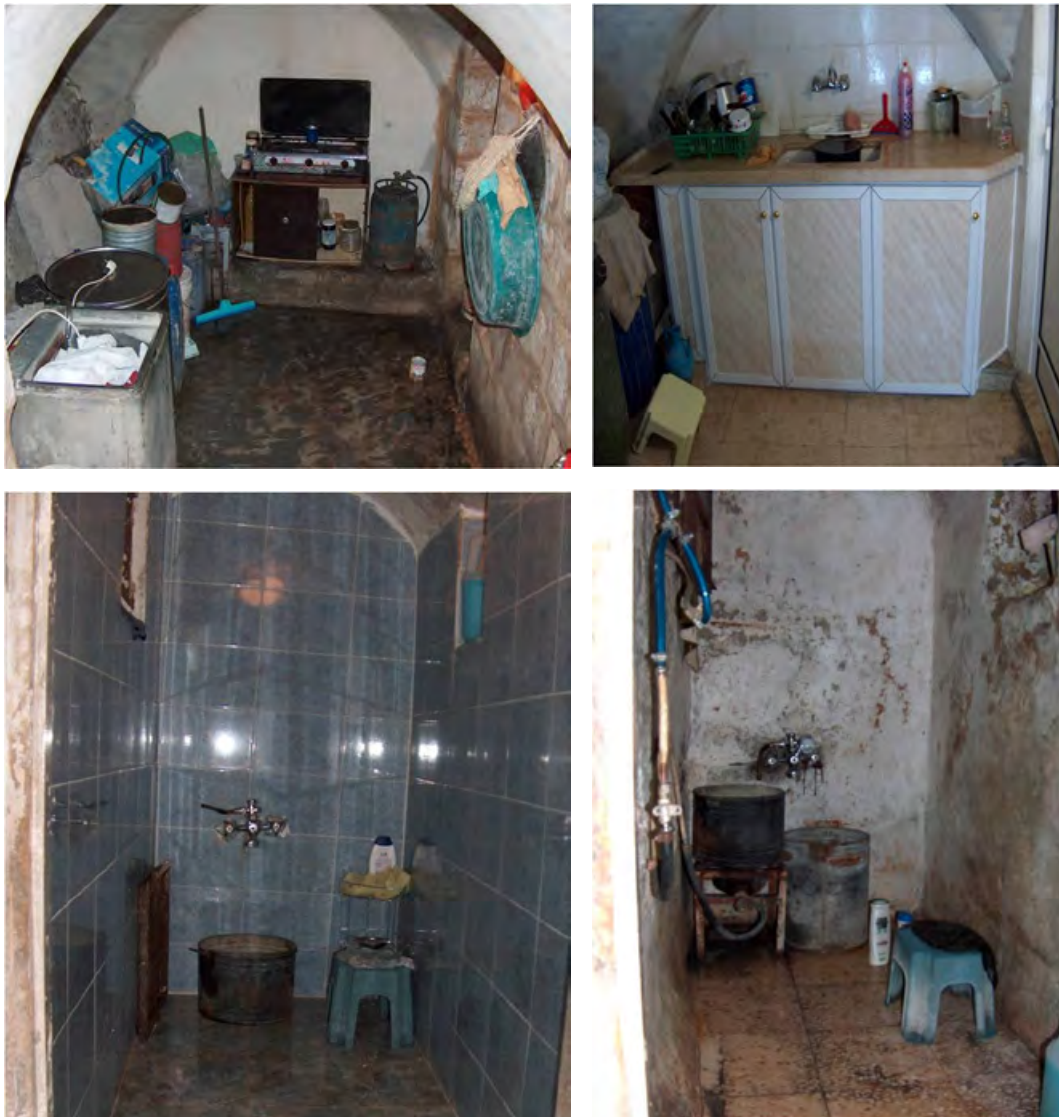
**Figgs. 93–96a.** Examples of poor houses project before and after

The next instalment was disbursed only after a site inspection to determine the progress of the project; the third instalment was paid on successful completion of the work. The total number of houses repaired inside the Old City was 331 and the total costs were around US\$800,000 (figg. 93-96a).

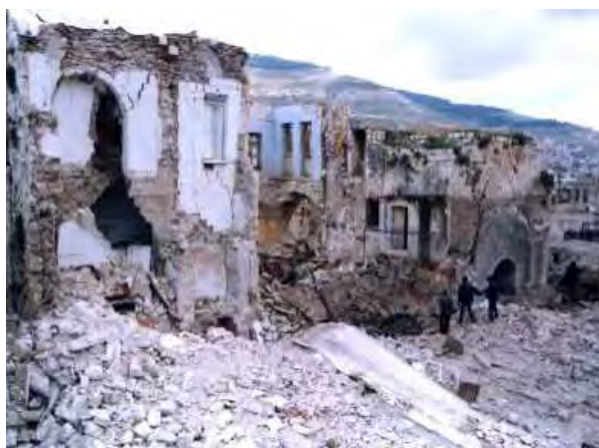
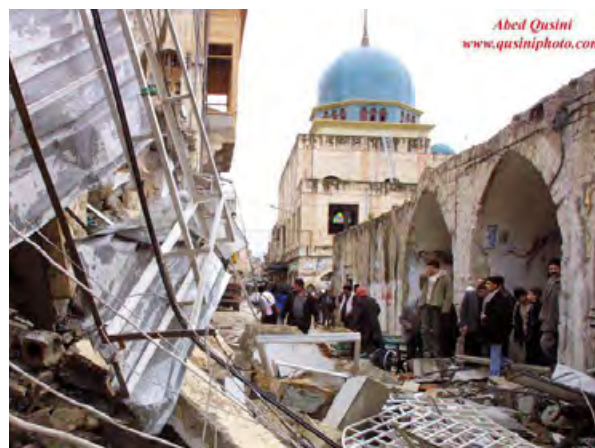
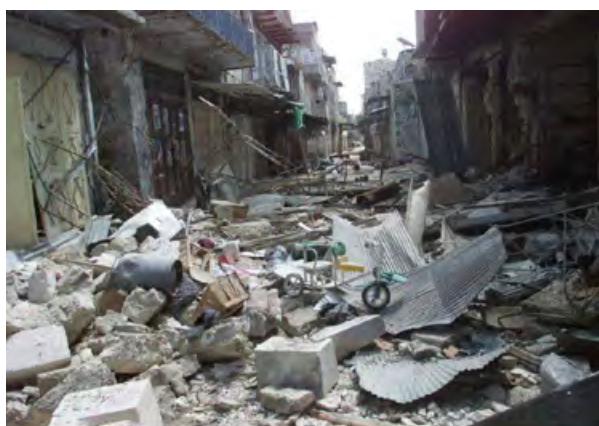
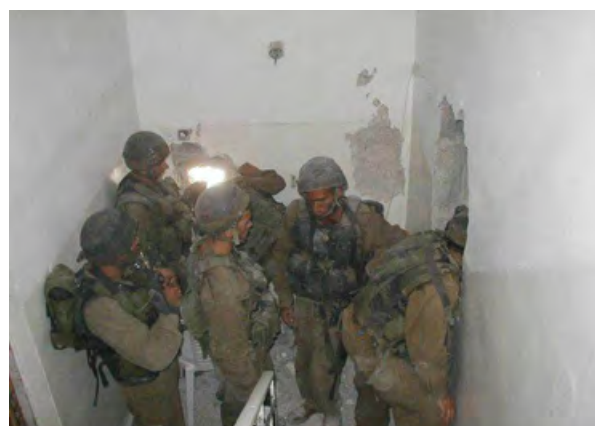
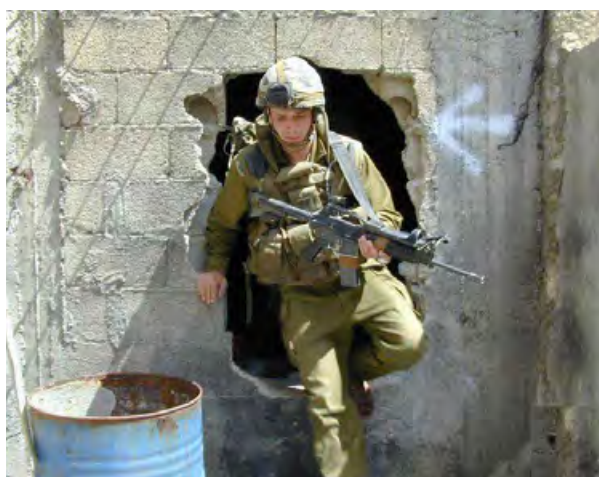
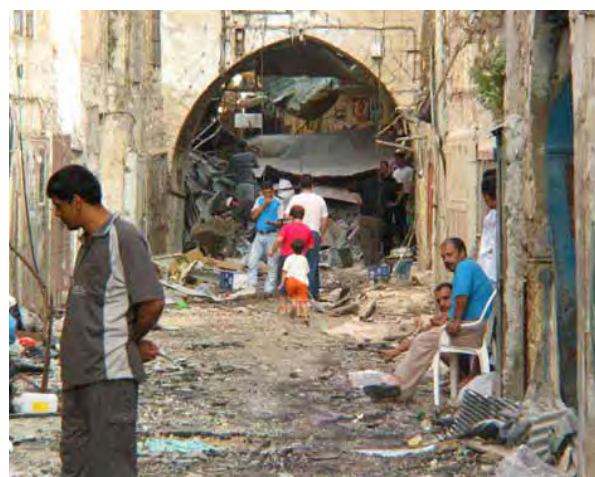
**Fig. 99–117.** Examples of destroyed structure by Israeli forces during the various invasions 2002–2004

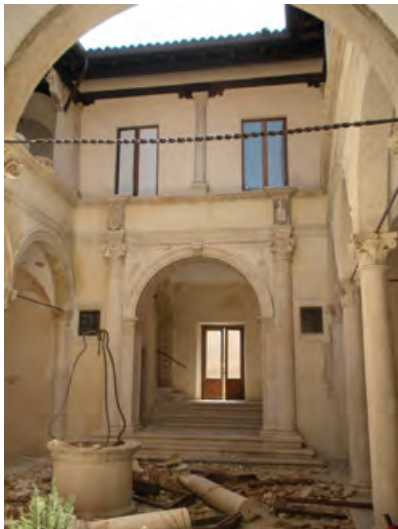
**Fig. 10.** Palazzo Carli Benedetti after the earthquake: the courtyard (ph. Bartolomucci 2009)

The 2009 earthquake caused serious damage to the Palazzo Carli-Benedetti: the collapse of the northern upper loggia in the courtyard, the loss of the corresponding eighteenth-century inner ceiling vault (figg. 10, 12), the partial ruin of the staircase wall (fig. 11) and the extensive damage to walls, most pronounced on the upper floor. Luckily, no loss of life occurred.

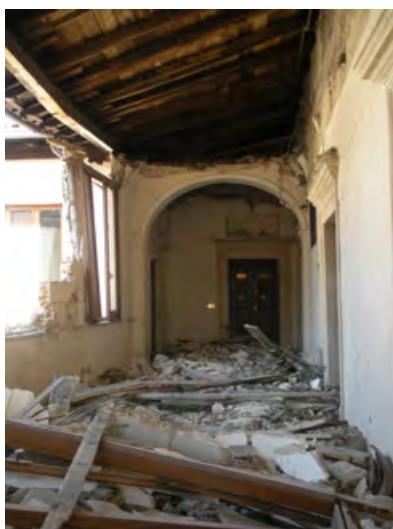
**Fig. 12.** Palazzo Carli Benedetti after the earthquake: the collapse in the loggia (ph. Bartolomucci 2009)

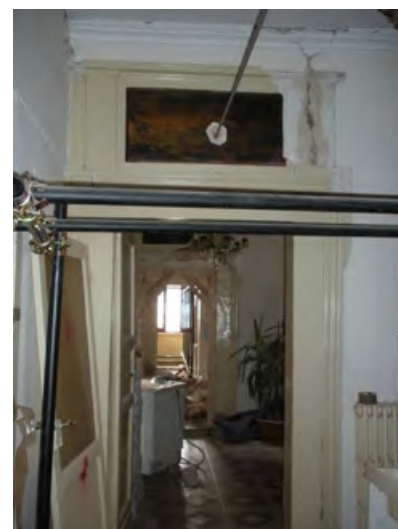
**Fig. 13.** The painted "sovrapporta" pierced by tie rods during the shoring work (ph. Bartolomucci 2010)

During these works, wall paintings were damaged by the insertion of metal wire ropes, which was done without the necessary attention to the decorative elements (fig. 13).<sup>7</sup> Moreover, some fragments of stucco frames and wall paintings were lost during the removal of rubble.

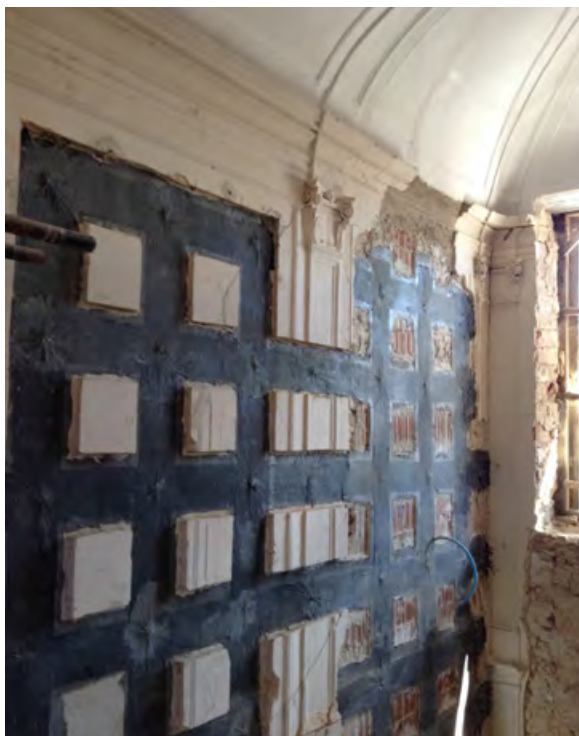
**Fig. 15.** The reconstruction of the loggia in progress: the collapsed columns have already been recomposed with anastylosis (ph. Bartolomucci 2015)

The final choice was to reconstruct the fallen wall using thin panels so as to leave the columns visible inside and outside (fig. 16). This means that the new structure is distinguishable from the still preserved eighteenth-century façades (Bartolomucci 2018: 115, 125).

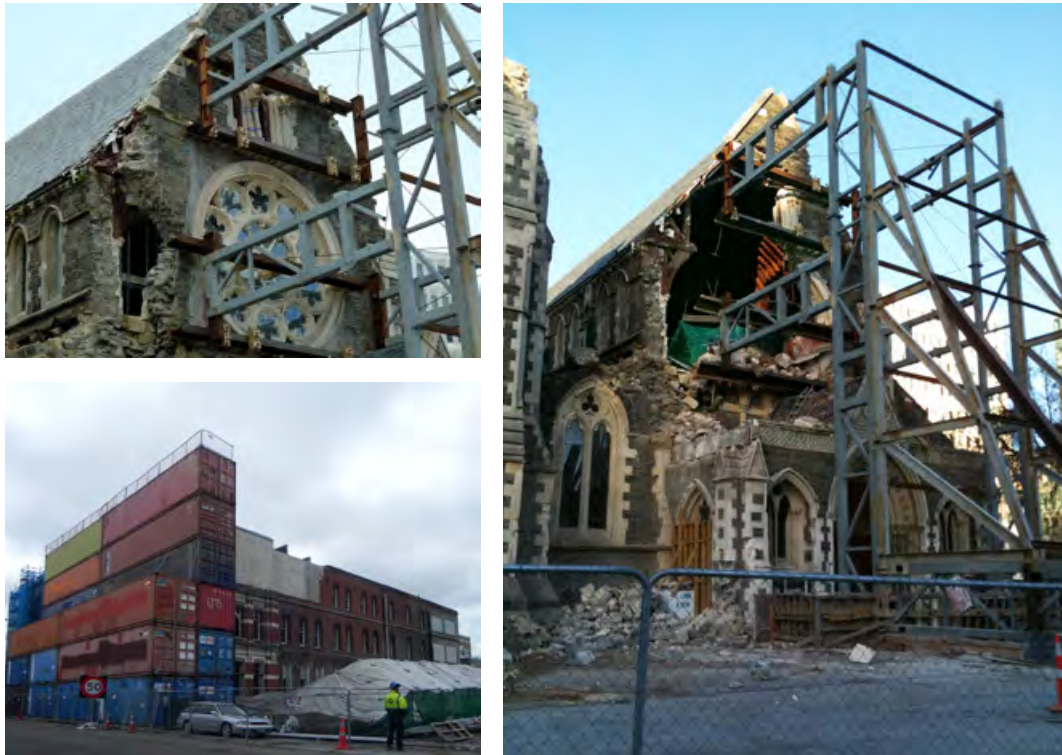
**Fig. 35.** Christ Church Cathedral with temporary structural framework to west façade. (Source: F. Wykes, 7 June 2011)

**Fig. 36.** Christ Church Cathedral showing damaged caused by temporary structural framework during aftershock. (Source: CCC heritage files, A. Marriott, 14 June 2011)
