**ICOMOS-ICCROM**  
ANALYSIS OF CASE STUDIES IN  
RECOVERY AND RECONSTRUCTION  
**CASE STUDIES**

Mostar, Bosnia and Herzegovina • Nablus, Palestine  
L'Aquila, Italy • Christchurch, New Zealand

**vol. 1**

# ANALYSIS OF CASE STUDIES IN RECOVERY AND RECONSTRUCTION

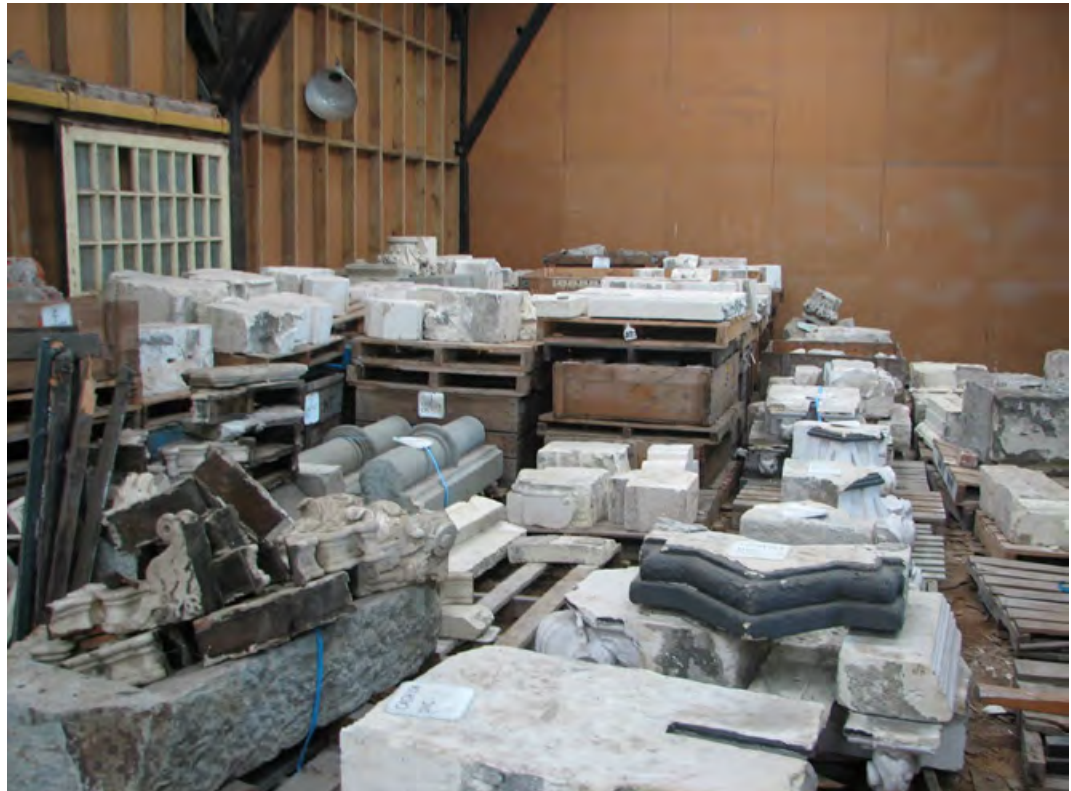
The reuse of salvaged heritage fabric was not as extensive as expected and much remains in storage (fig. 52).

**Fig. 52.** Heritage fabric in storage. (Source: CCC heritage files, G. Wright, 2018)

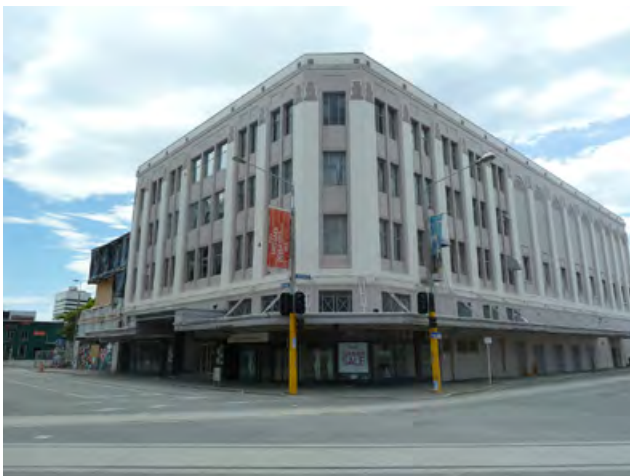
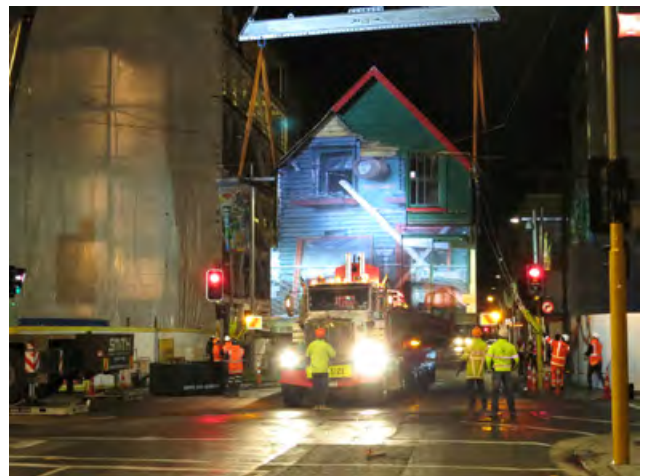
**Fig. 58.** Majestic Theatre (now demolished), corner of Manchester and Lichfield Streets. (Source: CCC Heritage files, 5 January 2012)

**Fig. 59.** Shands Emporium during relocation. (Source: CCC heritage files, M. Gerrard, 2015)

In some cases, the government's anchor projects required the removal of repairable heritage buildings or alterations to the historic street grid (e.g. demolition of the Majestic Theatre for road widening – fig. 58). New large-scale developments, enabled by site amalgamations, resulted in the loss or relocation of individual heritage buildings (e.g. Shands Emporium was relocated – fig. 59), but also the loss of the city's fine historic grain.

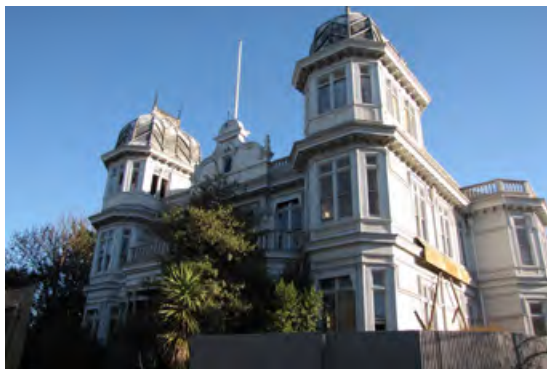
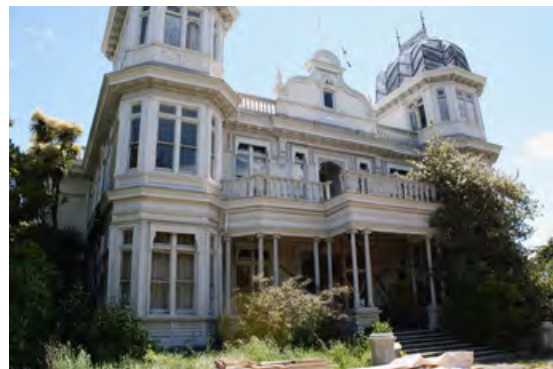
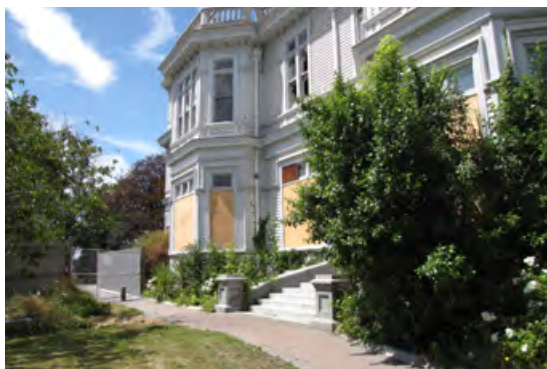
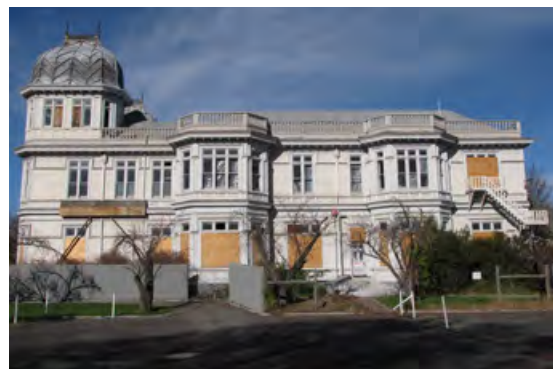
The building is still standing but needs levelling and strengthening. Temporary bracing has been installed, and ply panels have been fitted over damaged windows to prevent access and provide weather protection (figg.13, 15 and 16).

**Fig. 13.** McLean's Mansion, front (east) elevation showing twin towers with domed roofs (Source: CCC, June 2018)

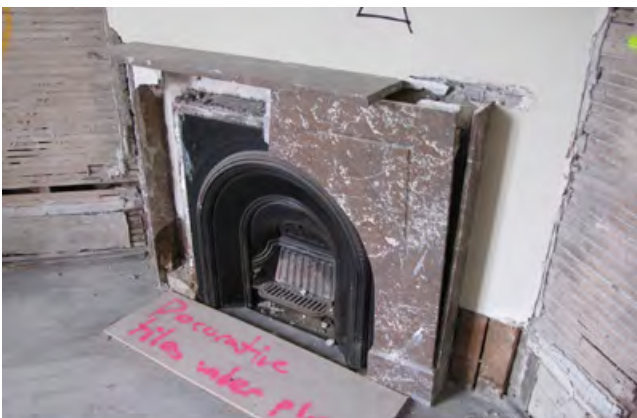
**Fig. 26.** Marble chimney pieces had been damaged. A protective sheet has been placed over hearth tiles (Source: CCC 28//1/2019)

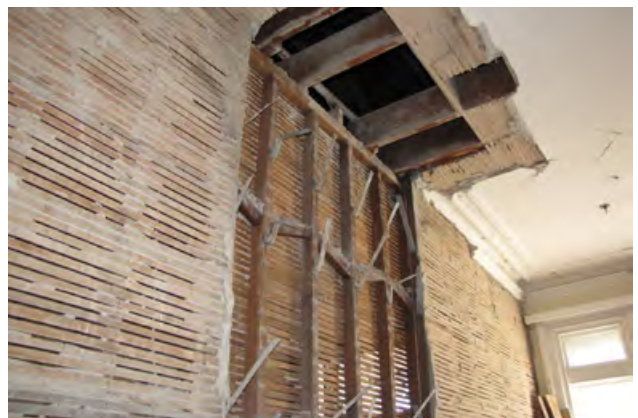
**Fig. 27.** Hole left by collapsed brick chimney breast (Source: CCC, 5/8/2019)

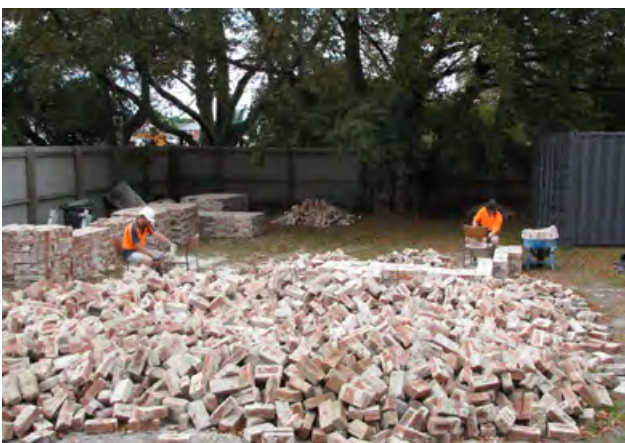
**Fig. 28.** Bricks have been salvaged, cleaned and stacked (Source: CCC 25/3/2019)

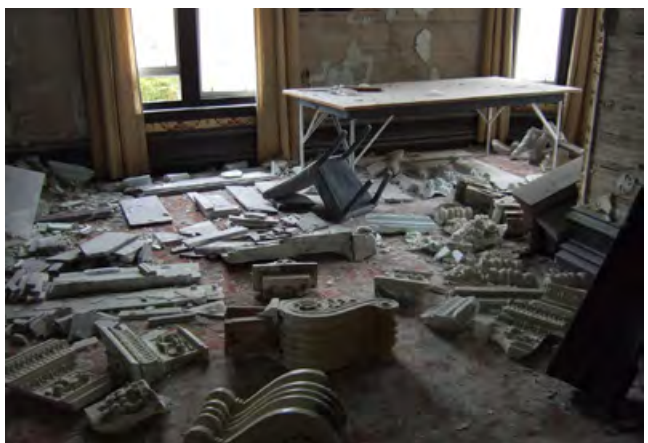
**Fig. 29.** Decorative plaster elements have been salvaged (Source: G Wright, CCC, 23/5/2013)

and decorative timber trim (skirtings, architraves, picture rails, wall panelling, etc.) are in a reasonable condition and can be readily restored (figg.17, 18 and 22). Many decorative plaster elements (e.g. ceiling roses, brackets) or portions of elements (e.g. moulded cornices) have been salvaged to enable replication and/or reinstatement during recovery (figg. 29 and 30).

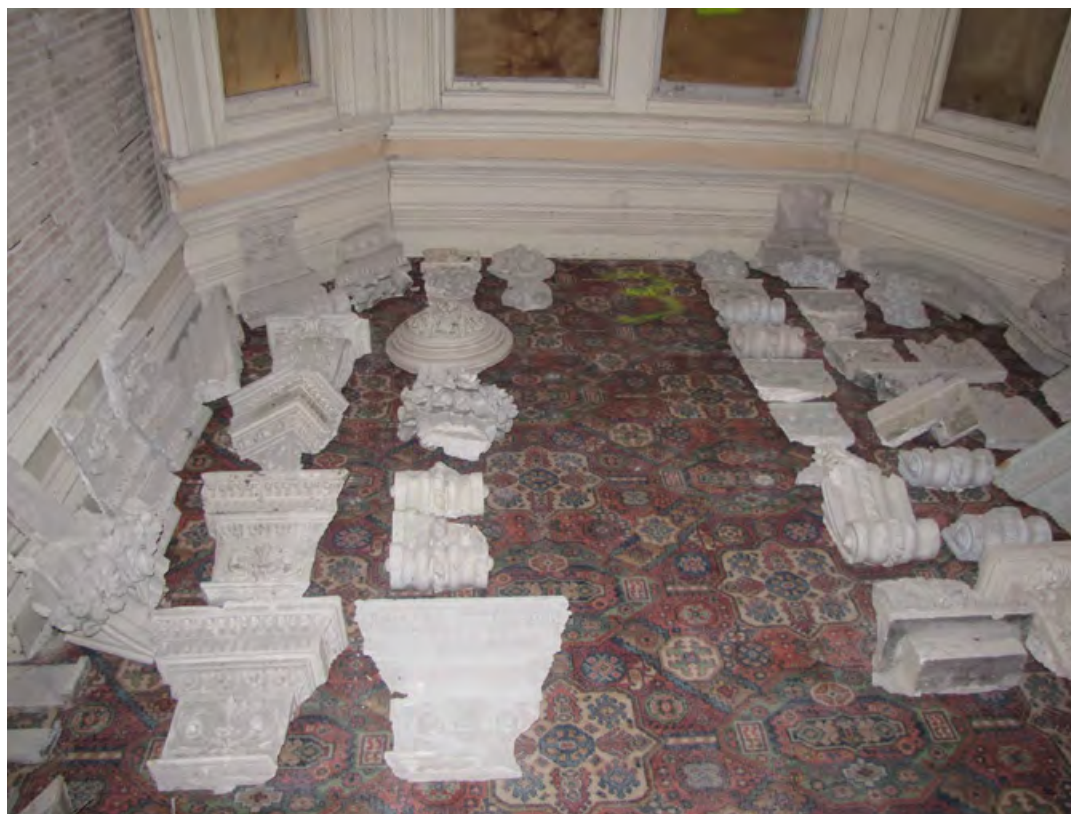
► **Fig. 30.** Plaster brackets have been salvaged, sorted, inventoried and stored for future reinstatement (Source: CCC 25/3/2019)

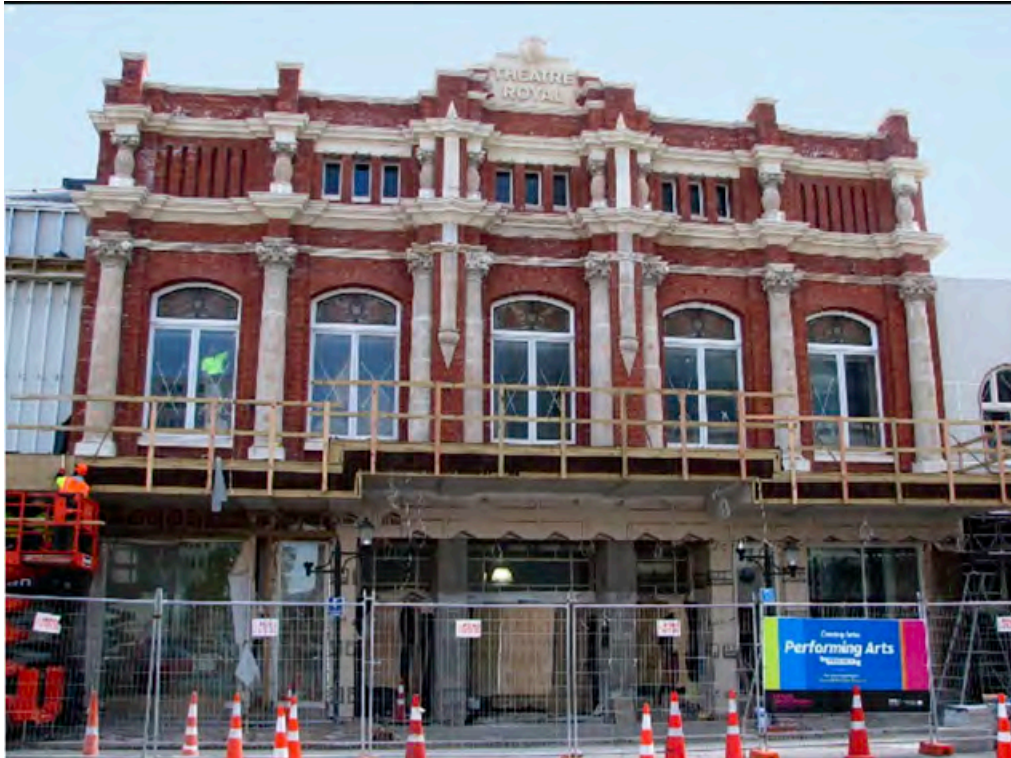
**Fig. 15.** The street façade is restored and the awning over the footpath is being reconstructed (Source: CCC, October 2014)

- full restoration of the front façade, including masonry repairs, new foundations and earthquake strengthening (fig. 15);
- some alteration to the building entrances at street level, where previous alterations had already taken place (fig. 16);
- construction of a new foyer and visitor facilities to 100 per cent NBS, including reinstatement of the 1928 staircase linking the stalls and dress circle foyers;

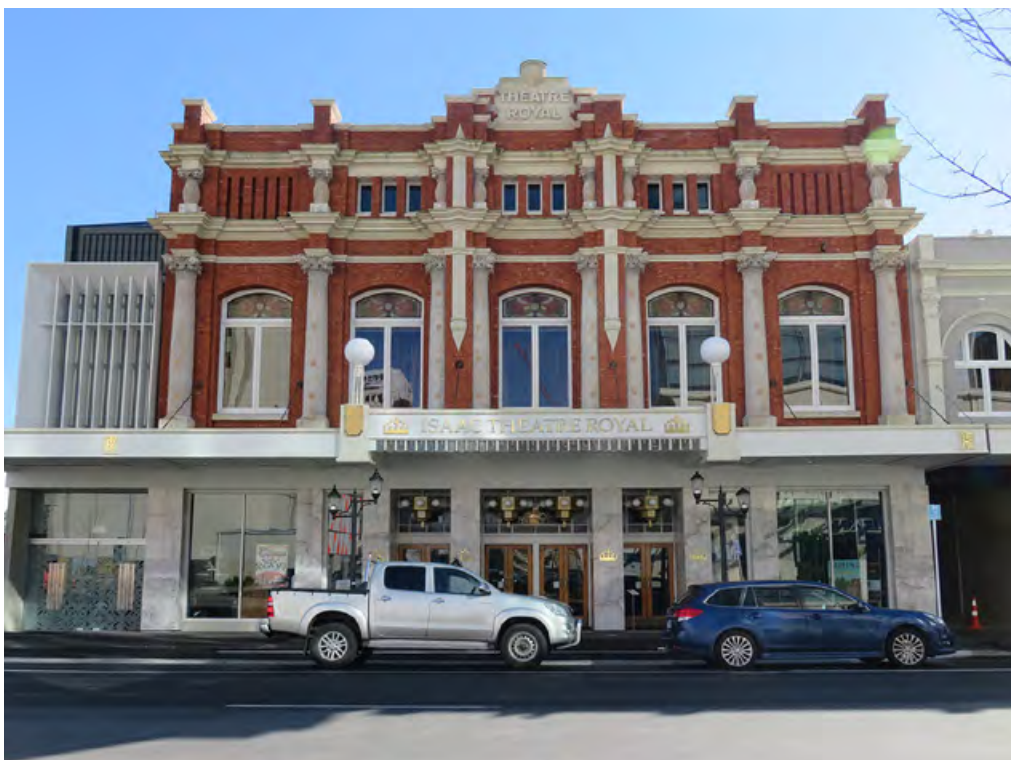
**Fig. 16.** The Theatre façade has been fully restored, but with modifications at street level to accommodate new foyer facilities and egress requirements. The new fire stairs and lifts are located in the new structure on the left of the theatre. (Source: C Forbes, September 2016)

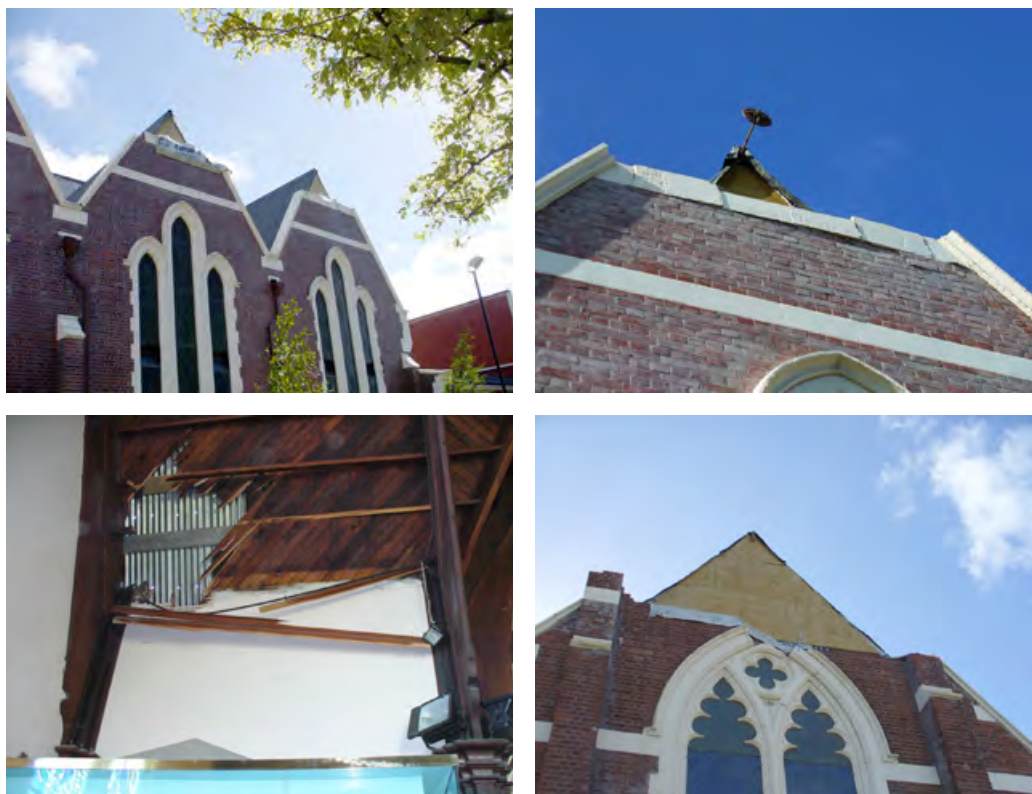
**Fig. 7.** September 2010 earthquake damage to southern gables (Source: CCC, 27/1/2011)

**Fig. 8.** September 2010 earthquake damage to northern gable showing iron tie rod from previous seismic upgrade works (Source: CCC, 27/1/2011)

**Fig. 9.** September 2010 earthquake damage to western gable (Source: CCC, 27/1/2011)

**Fig. 10.** September 2010 earthquake damage to ceiling of church (Source: CCC, 27/1/2011)

The September 2010 earthquake caused damage to the tops of all eight gables of the church (collapse of each masonry apex), and some damage to the timber ceiling of the church (figg. 6, 7, 8, 9 and 10).

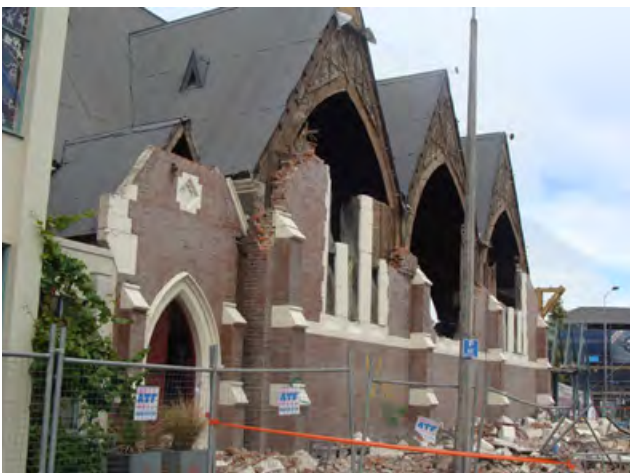
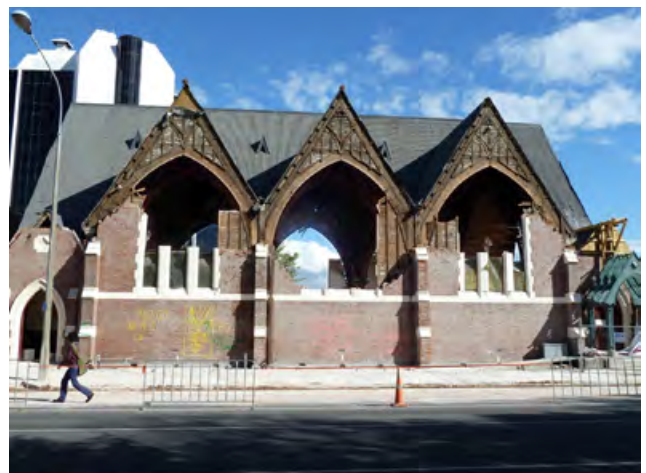
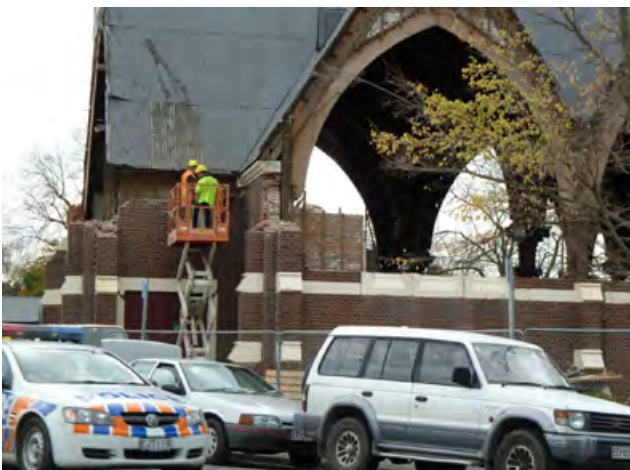
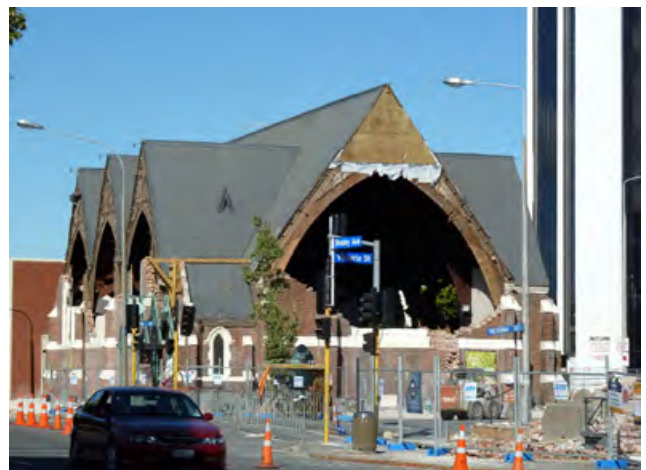
The February 2011 earthquake caused major collapse of the outer masonry walls down to windowsill level (figg. 11, 12, 13 and 14). The internal timber structure, comprising columns, roof trusses and boarded ceilings, remained standing. The internal timber dado wall linings also remained standing, although the lathe and plaster above were severely damaged. Many of the pews and other furnishings survived because they were protected by the timber structure. The organ sustained some minor damage, but the stained glass windows were lost.

**Fig. 11.** February 2011 earthquake damage to northern gables and northeast porch (Source: CCC, February 2011)

**Fig. 12.** February 2011 earthquake damage to northern gables showing exposed timber structure and back of internal lathe and plaster wall linings (Source: CCC, 15/3/2011)

**Fig. 13.** February 2011 earthquake damage to western gable with ply added to protect timber structure (CCC, 15/3/2011)

**Fig. 14.** Undertaking detailed damage assessment following February 2011 earthquake (Source: CCC, 2/6/2011)

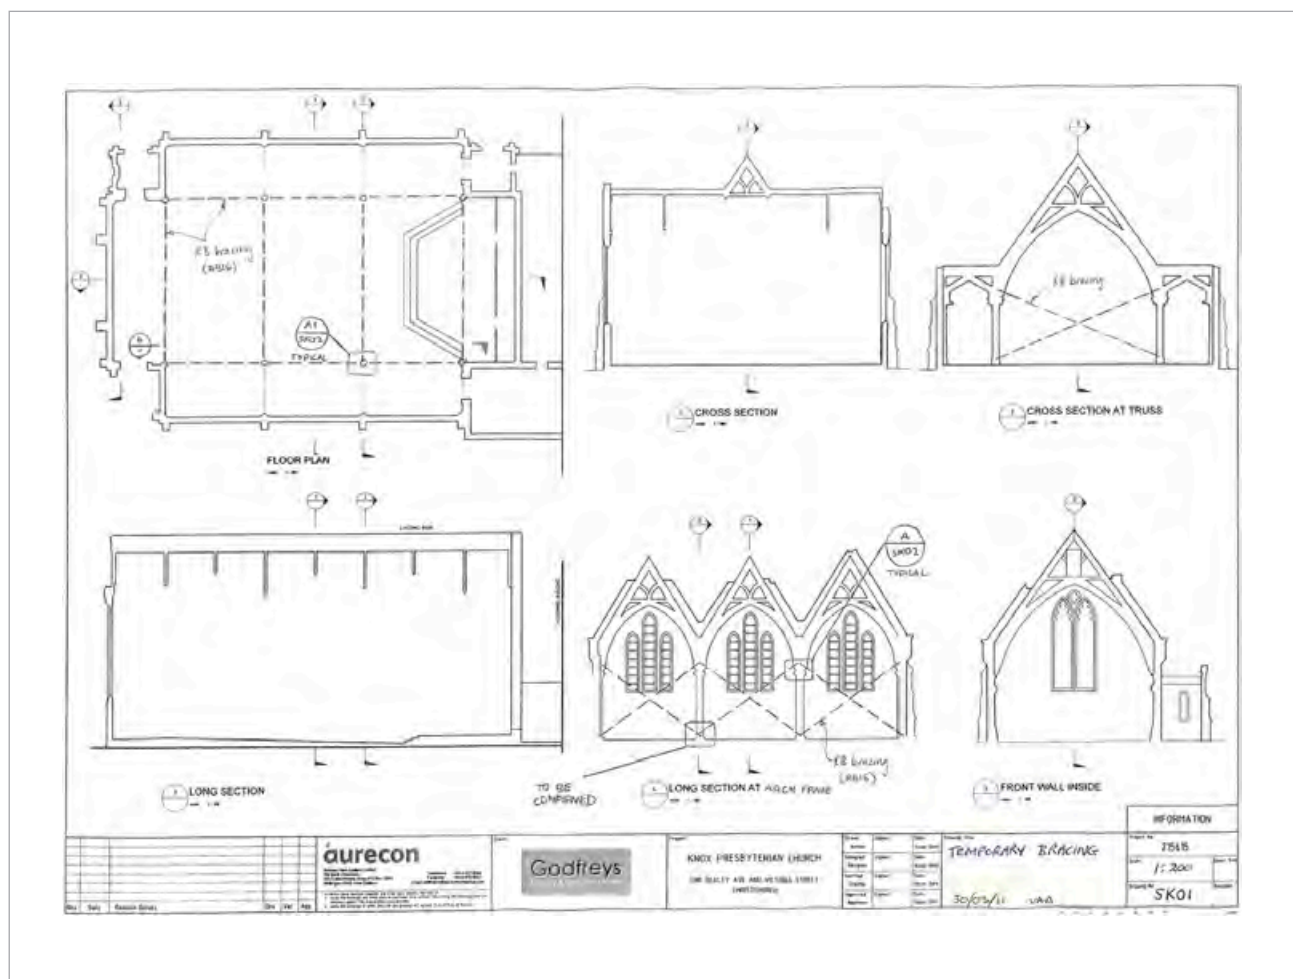
▼  
**Fig. 16.** Drawings of Knox Church, prepared by Aurecon (30/3/2011), showing the proposal for temporary bracing (Source: CCC, 2011)

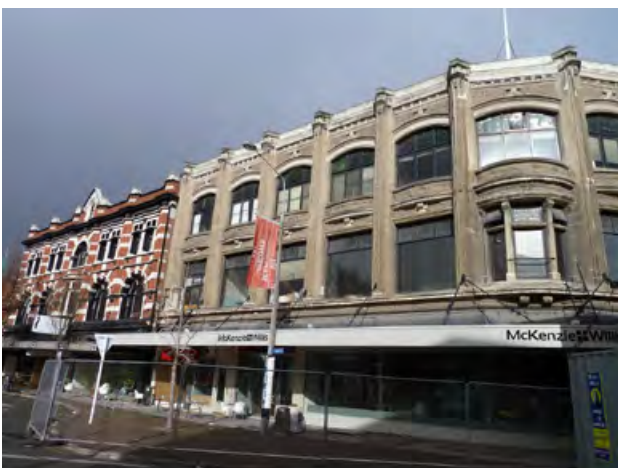
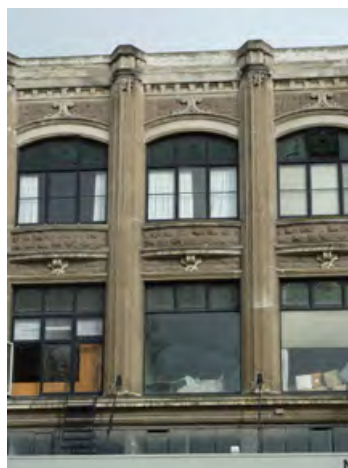
- 4 September 2010 – minor damage (figg. 5 and 6)
- 26 December 2010 – minor damage
- 22 February 2011 – severe damage
- 13 June 2011 – severe damage
- 23 December 2011 – moderate damage

◀ **From left to right:**  
**Fig. 5.** McKenzie and Willis building post September 2010 earthquake (Source: Carole-Lynne Kerrigan, n.d.)  
**Fig. 6.** McKenzie and Willis building post September 2010 earthquake (Source: Carole-Lynne Kerrigan, n.d.)

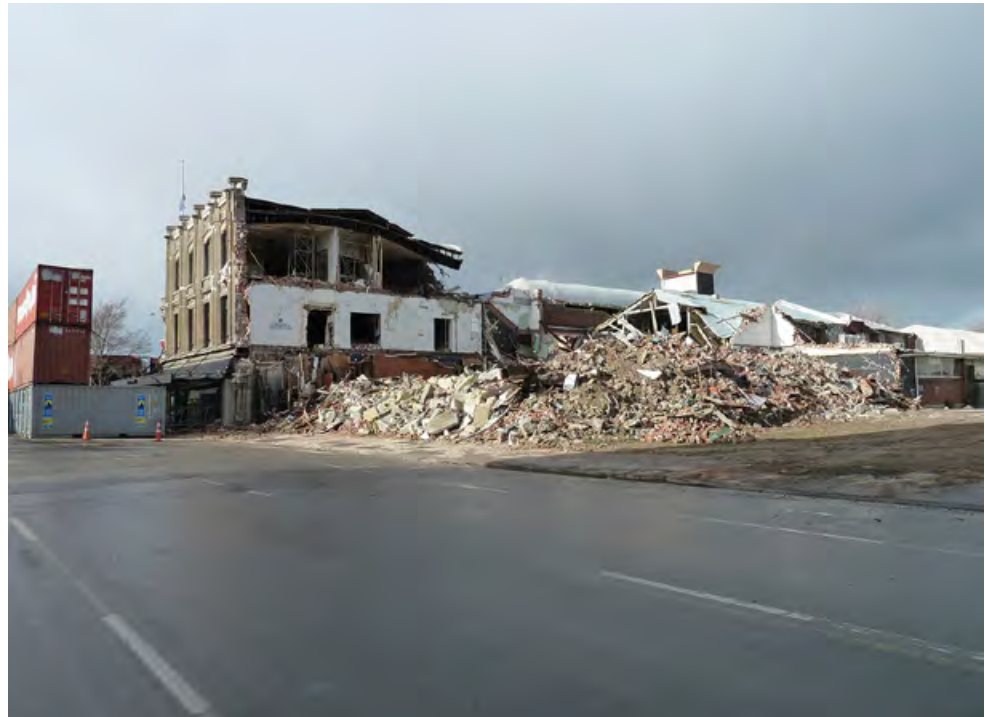
**Fig. 7.** The McKenzie and Willis Building following the February 2011 earthquake, showing collapse of the buildings to the rear and demolition of the surrounding commercial buildings, including the adjoining A J Whites Store to which the McKenzie and Willis building was added in 1909. The McKenzie and Willis building has been severely damaged (Source: Carole-Lynne Kerrigan, n.d.)

unreinforced masonry (URM) construction. The McKenzie and Willis Building shared party walls with neighbouring buildings, one of which collapsed during the February 2011 earthquake (former A J White building at 232 Tuam Street) (figg. 7 and 8) and another of which was destroyed by fire soon afterwards (Billen's Camping Building, 167–177 High Street).

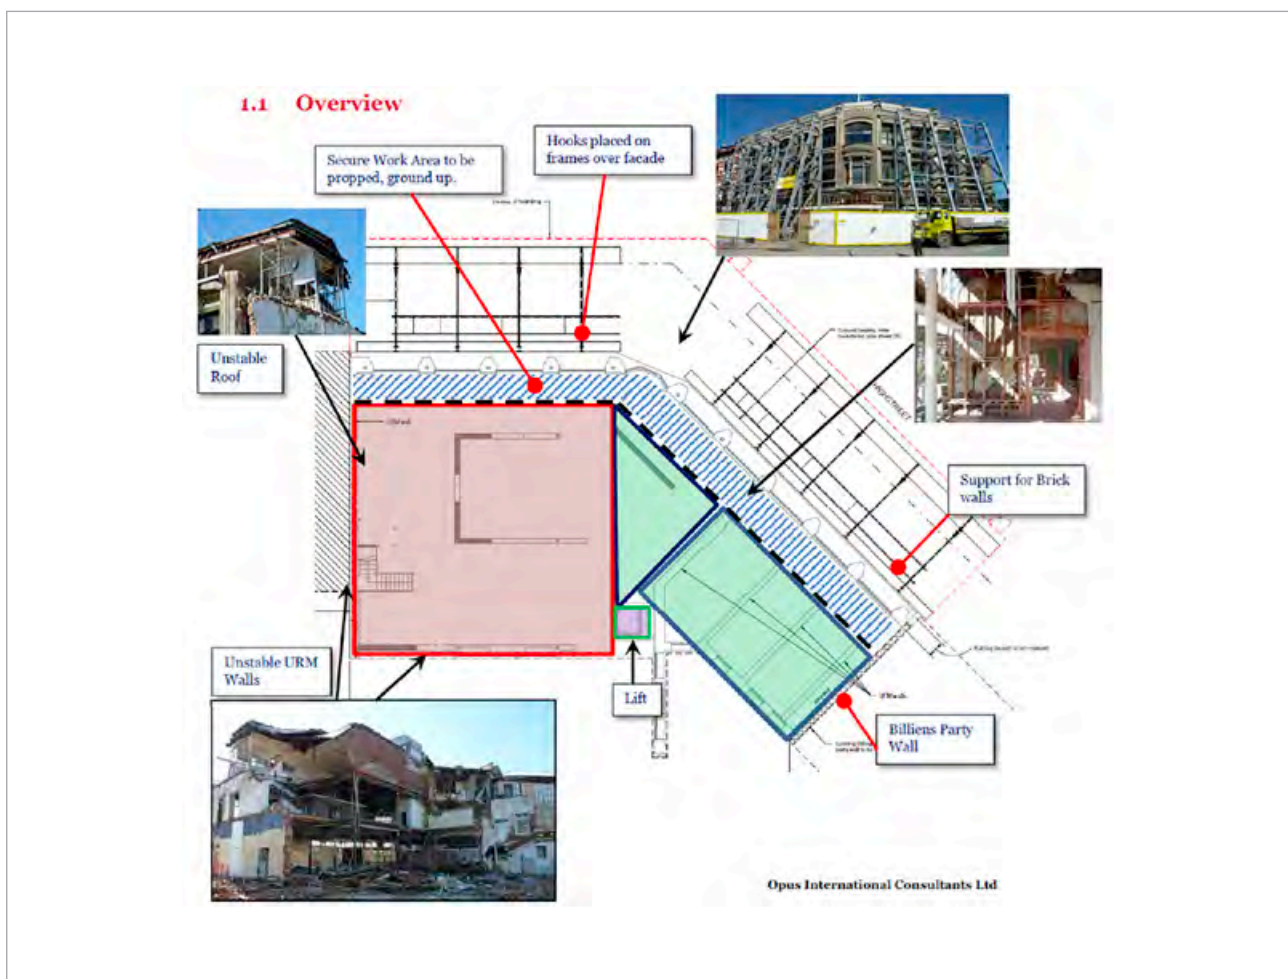
**Fig. 9.** Diagram showing Opus methodology for façade stabilisation and staged demolition of the buildings to the rear (Source: Opus International, 2012)

Marriott acknowledged that the building in general was too badly damaged to be retained, but recommended that the façade be retained, and that a temporary propping system be installed to support the façade whilst a permanent structure was designed and built to support it (CCC Memorandum 2011).

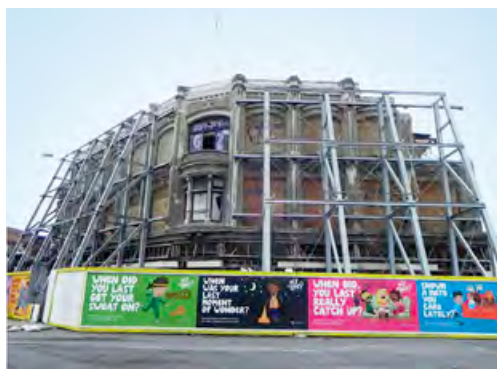
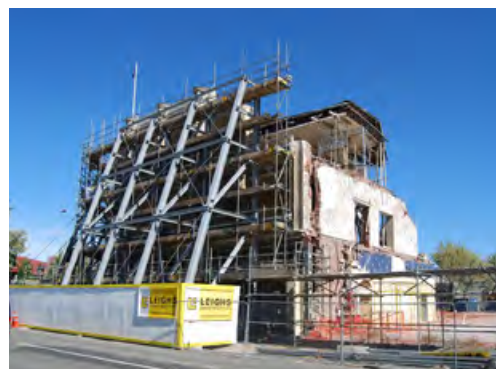
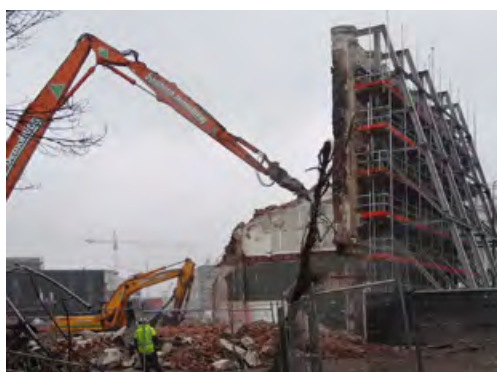
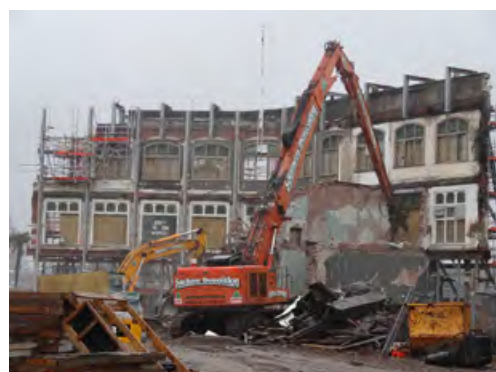
**Fig. 10.** Front façade has been stabilised to allow demolition of the building behind (Source: M Vair-Piova, CCC, 5 December 2015)

**Fig. 12.** Demolition of the building to the rear of the McKenzie and Willis façade (Source: Mike Vincent, HNZPT, 23 September 2015)

**Fig. 13.** Stabilised façade during demolition works (Source: Mike Vincent, HNZPT, 23/9/2015)

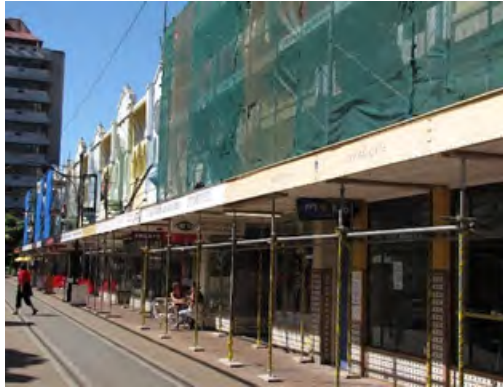
**Fig. 10.** New Regent Street looking north showing scaffold and repairs underway, whilst shops continue to trade, 16 February 2011. (Source: CCC, February 2011)

The 2010 earthquakes caused superficial cracking of render and plaster finishes. While repairs were undertaken, the shops were able to stay open and the tram was able to keep running (figg.10 and 11).

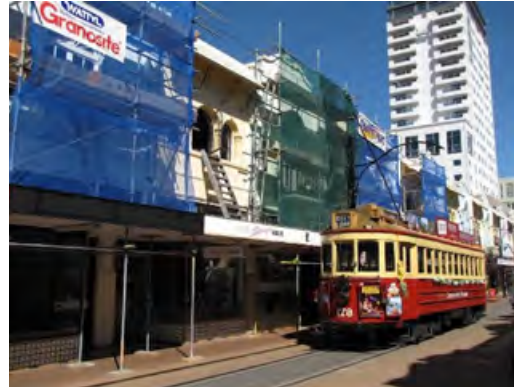
**Fig. 11.** New Regent Street looking south showing the tram operating whilst repairs are undertaken to the building façade, 16 February 2011 (Source: CCC, February 2011)

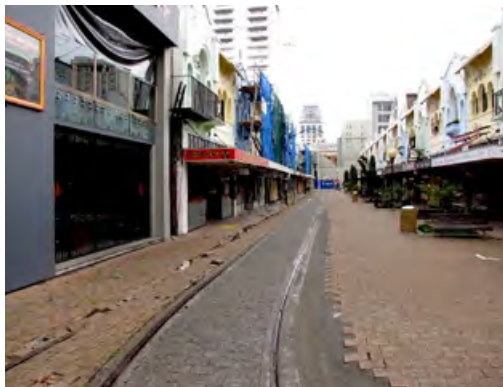
**Fig. 12.** Earthquake damage to one of the shop fronts, New Regent Street (Source: CCC, June 2011)

During the 2011 earthquakes, the glazed shopfronts and lathe and plaster ceilings were damaged, with structural cracks appearing in the walls, and some of the rear masonry walls failing where there was a greater concentration of openings (figg. 12 and 13). There was also minor cracking in the parapets and

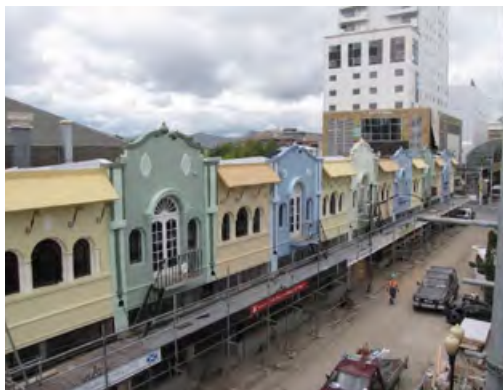
**Fig. 14.** New Regent Street looking south, showing subsidence in the street as a result of liquefaction (Source: CCC, June 2011)

projecting concrete awning panels, although none collapsed. Liquefaction caused damage to the street paving and severe damage to the drainage system (fig. 14).

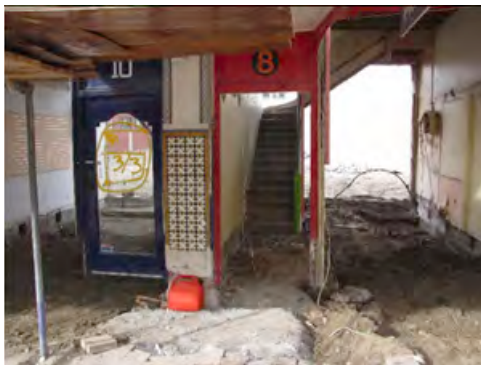
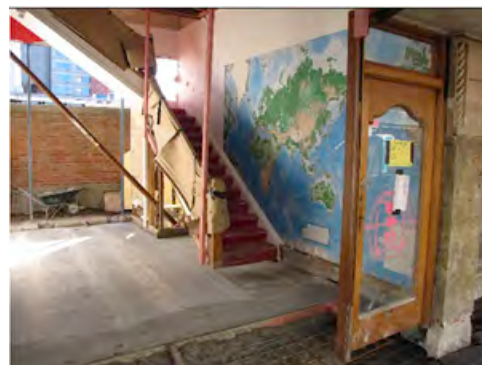
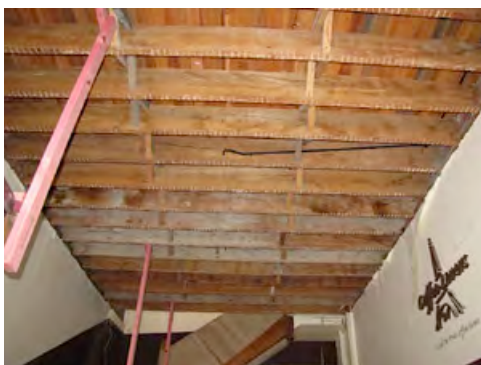
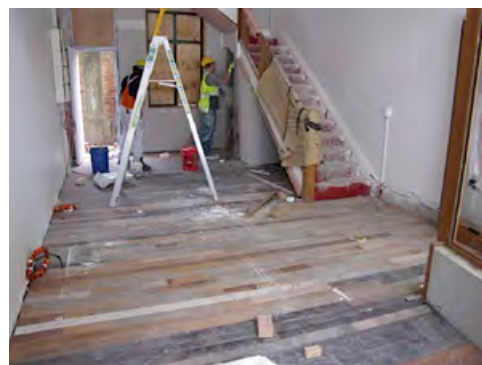
**Fig. 18.** Shopfronts and interiors of units 8 and 10. Floor has been removed, but the doors, tiles and stairs have been retained in situ throughout the repair and refurbishment work (Source: CCC, August 2012)

**Fig. 21.** Lathe and plaster ceilings were stripped to be replaced by structural diaphragm sheeting (Source: CCC, August 2012)

- insertion of concrete floors at ground floor level (figg. 18, 19 and 20);
- strengthening the connections between the upper timber floor/ceiling structures and the walls to create structural diaphragms (fig. 21);

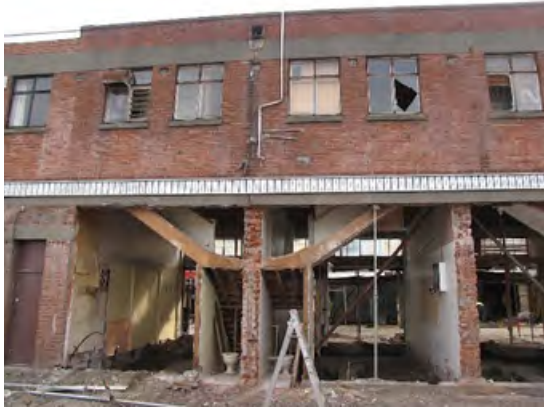
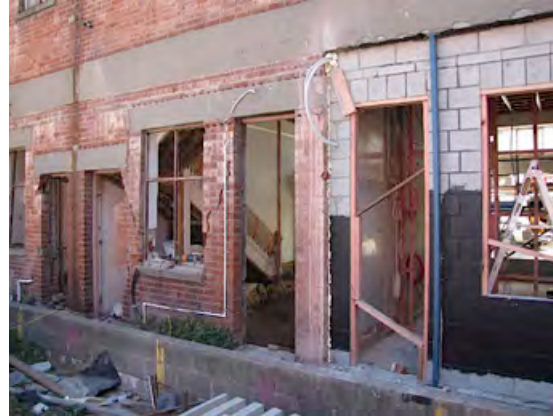
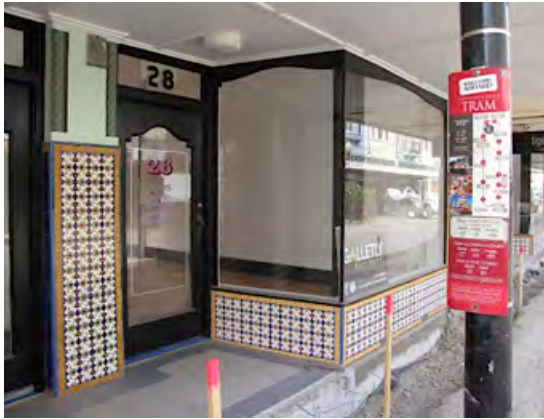
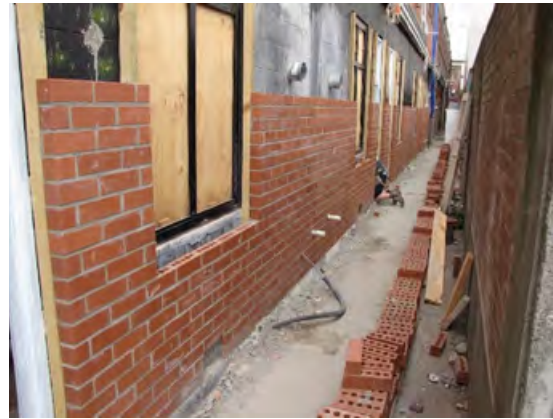
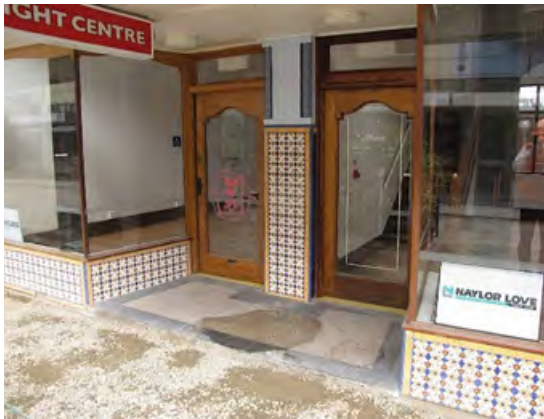
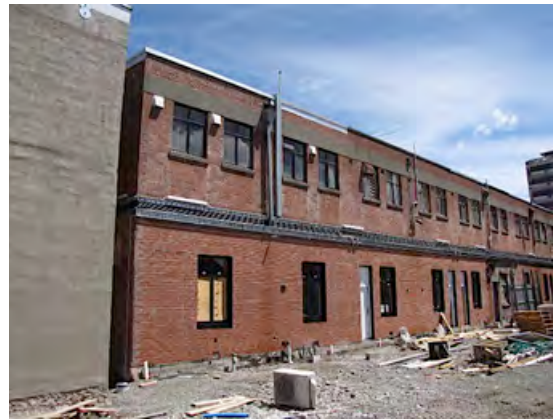
**Fig. 22.** Brickwork of rear elevation deconstructed for repair (Source: CCC, August 2012)

**Fig. 26.** Repaired shopfront, showing the original doors, tiles and terrazzo threshold. The new steel supports can be seen through the windows (Source: CCC, March 2013)

**Fig. 27.** Repaired shopfront, showing original doors and reinstated tiles. The new steel supports can be seen through the windows (Source: CCC, March 2013)

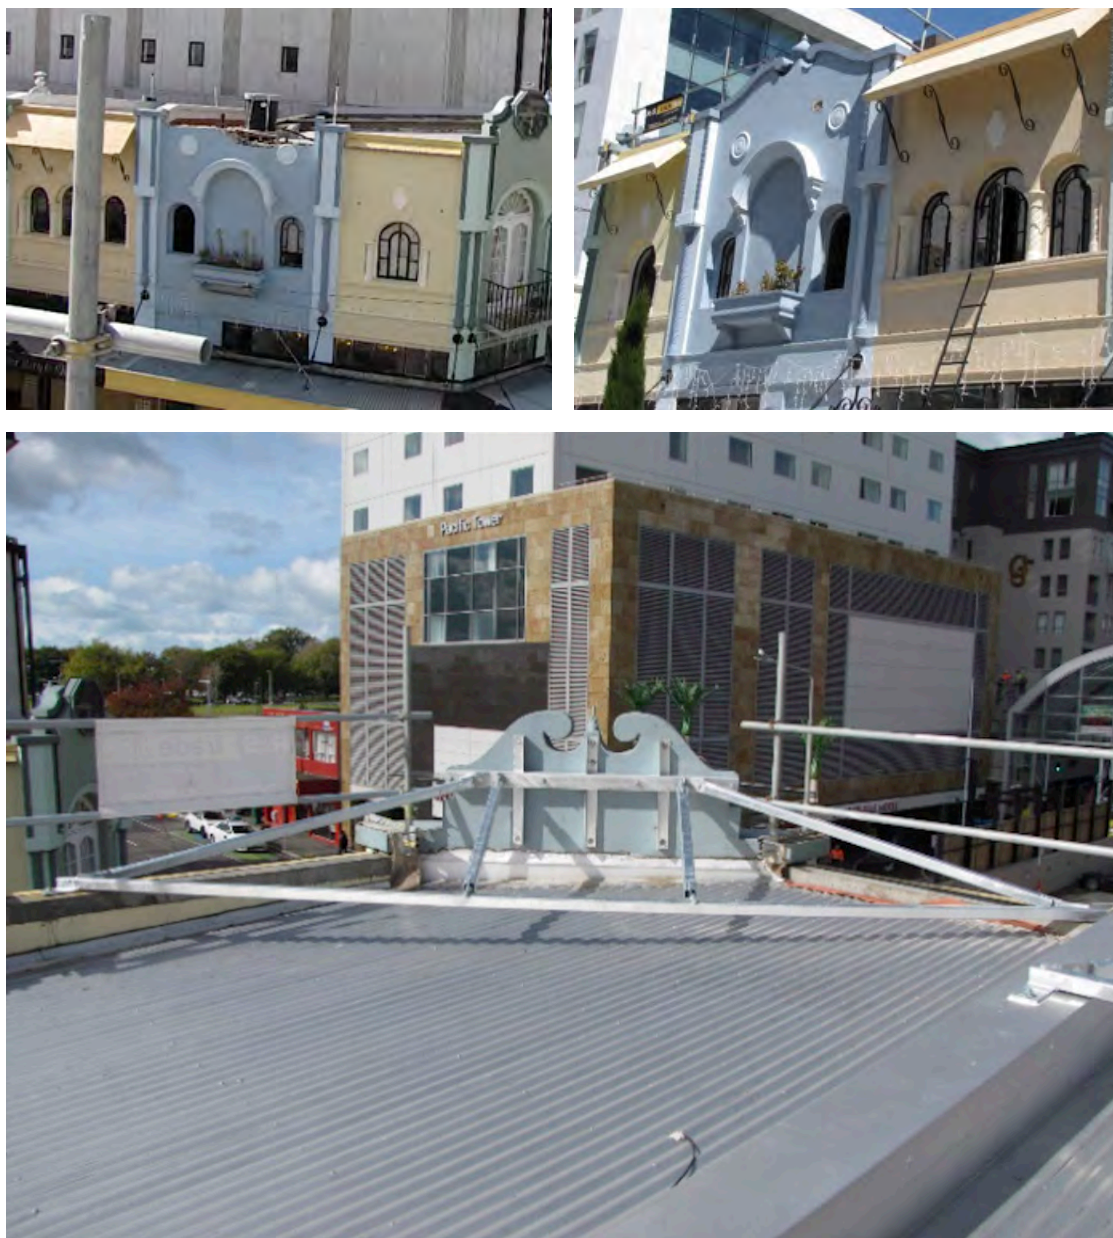
In March 2016, additional damage was discovered to the parapets and "eyelid" features over the central windows and doors. This resulted in the decision to structurally upgrade these elements with the associated further disruption to businesses in the street.

**Fig. 28.** Parapet damaged during 2016 earthquake disassembled for reconstruction and strengthening (Source: CCC, April 2018)

In 2016 the parapets were strengthened and the "eyelids" over the central windows and doors were replaced with lightweight replicas (figg. 29 and 30).

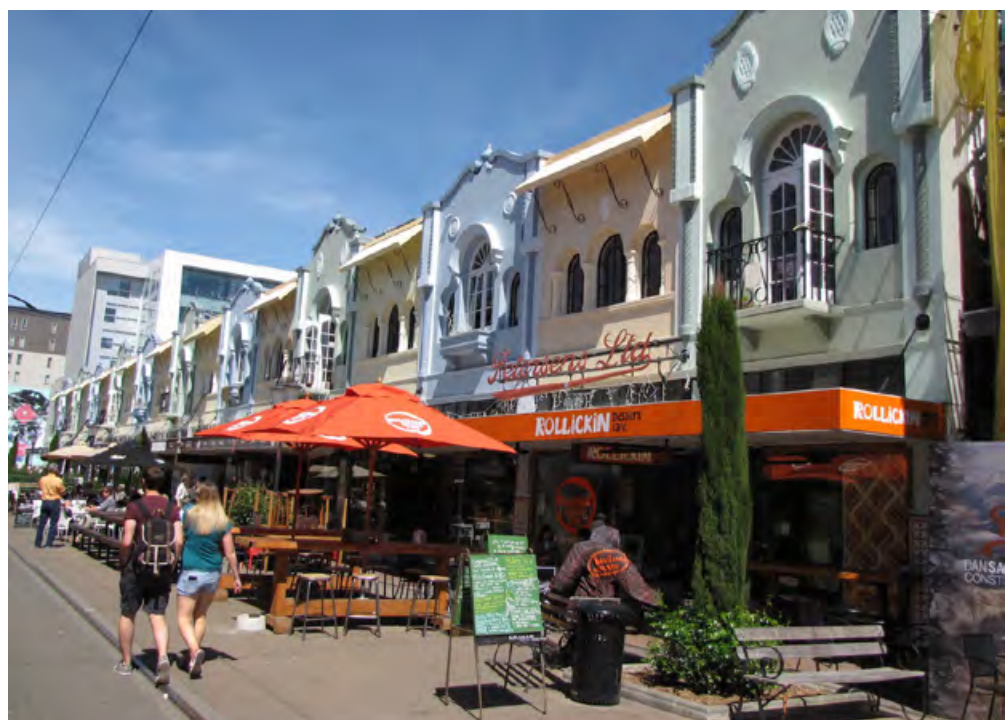
**Fig. 32.** New Regent Street looking south following completion of repairs (Source: CCC, October 2018)
